LANDSLIDE INVENTORY AND LAND-USE MAPPING, DEM PREPARATION, PRECIPITATION THRESHOLD VALUE AND ESTABLISHMENT OF EARLY WARNING DEVICES

March 2012

Rainfall Triggered Landslide Hazard Zonation in Cox's Bazar & Teknaf Municipalities as well as Introducing Community-based Early Warning System for Landslide Hazard Management

Revised Report on Landslide Inventory and Land-use Mapping, DEM Preparation, Precipitation Threshold Value & Establishment of Early Warning Devices

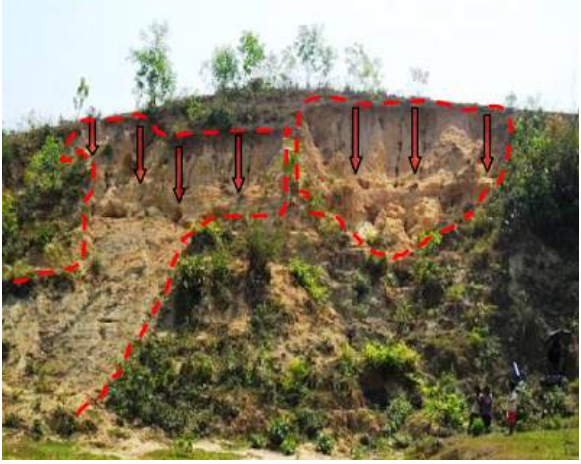
<p>Landslide ID: 09 Location: South Ganar Ghona, Cox's Bazar district</p>	<p>Coordinates: N-21°25'00.5", E-92°01'04.6"</p>

<p>Present Surface Level Scale: 1cm = 2m</p>
<p>Date of Occurrence: 15 June 2010, 3 July 2008 and 11 June 2007. (The Landslide Occurred around 6:00am due to heavy rain.</p>	<p>Landslide History: Initiated movement in June 2007, Subsequently activated in July 2008 and June 2010.</p>
<p>Rainfall: June 11, 2007: 101 mm during 24 hours and 240mm during 7 days (continuous rain from 4 to 11 June). July 3, 2008: 134 mm during 24 hours and 729mm during 7 days (continuous rain from 27 June to 3 July). June 15, 2010:</p>	
<p>Geology: The failed slope is western scarp of a large escarpment with a height of around 15m. The height of the failed part of the slope is around 12m and width is around 60 m. The mountain forming bed rock of the escarpment is formed of mainly two lithological units- lower bluish gray thinly laminated moderately weathered shale unit and upper moderately weathered yellowish brown cross-bedded to massive medium- to fine-grained sandstone and the top part of this unit about 3 m is highly weathered. The failed mass comprised of highly weathered rock and moderately weathered rock. After the slide at places a moderately weathered rock is exposed. The exposed rock units are mostly composed of light brown fine to medium grained sand, silt and clay. The height of the failure surface is around 12 m.</p> <p>Fracturing: Three sets of joints are observed on failure surface of the bed rock and one is parallel to the bedding plane (158/15) and other two are almost vertical and perpendicular to each other (260/85 and 100/89). The joints are filled with weathered clay, silt and fine sand.</p> <p>Overburden Deposits: Total overburden comprised of clay, silt and sand material. The material contains the relic structure of the bed rock which suggests it to be residual soil. The soil thickness of the residual soil layer which overlays the bed rock mass is around 1 m thick. The thickness of colluvial soil is around 4m.</p>

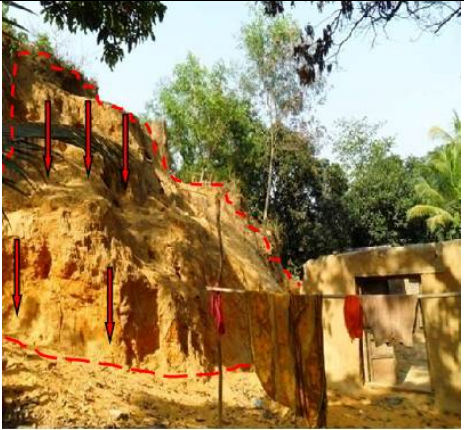
<p>Landslide ID: 21</p> <p>Location: South Ganar Ghona, Cox's Bazar district</p>	<p>Coordinates: N-21°25'02.2", E-92°00'54.9"</p>

Date of Occurrence: 15 June 2010. The Landslide Occurred around 5:00am due to heavy rain.		Landslide History: Landslide occurred here in June 2010.	
<p>Geology: The height of failed part of the slope is around 5m and width is around 20m. The exposed rock units are mostly composed of light brown silt, and fine to medium grained sand; locally contains debris derived from local bedrock. Lithology of this area is mainly Sand. The bed rock is massive and loose sediments in the upper part and lower part is well consolidated. The failed mass comprised of completely weathered rock and highly weathered rock. After the slide at places a moderately weathered rock is exposed. The height of the failure surface is around 5m.</p> <p>Fracturing: Sets of joints are not observed on failure surface of the rock.</p> <p>Overburden Deposits: Total overburden comprised of clay, silt and fine sand materials. The material contains the relic structure of the bed rock which suggests it to be residual soil. The soil thickness of the residual soil layer which overlays the bed rock mass is around 1m thick.</p>

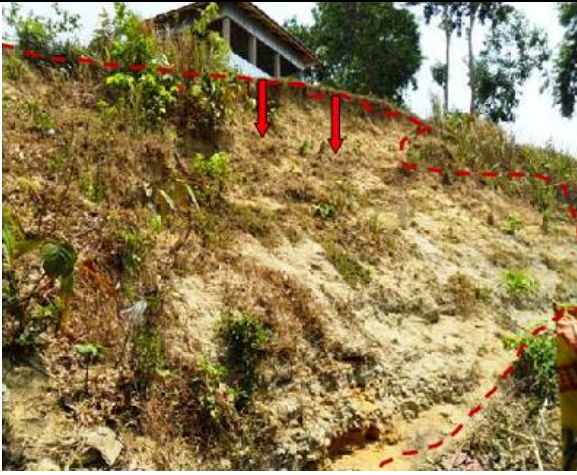
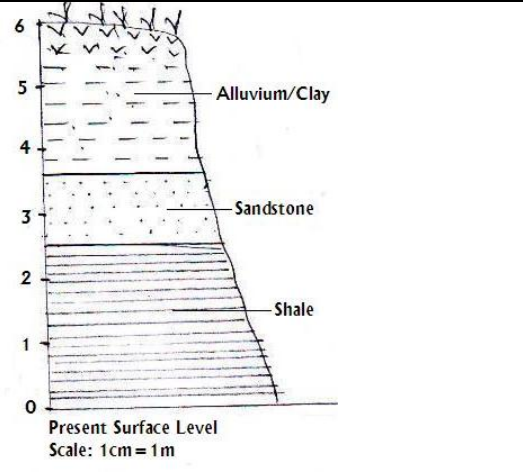
Landslide ID: 47 Location: Adorsha Gram, Cox's Bazar district		Coordinates: N-21°24'47.6", E-91°59'30.9"

Date of Occurrence: 15 June 2010. Rainfall:		Landslide History: Landslide occurred here in June, 2010.

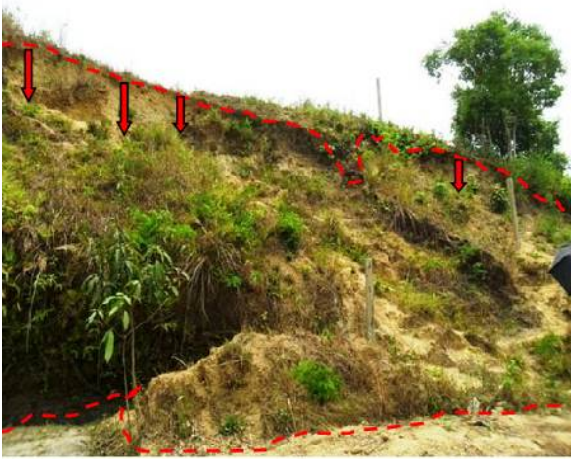
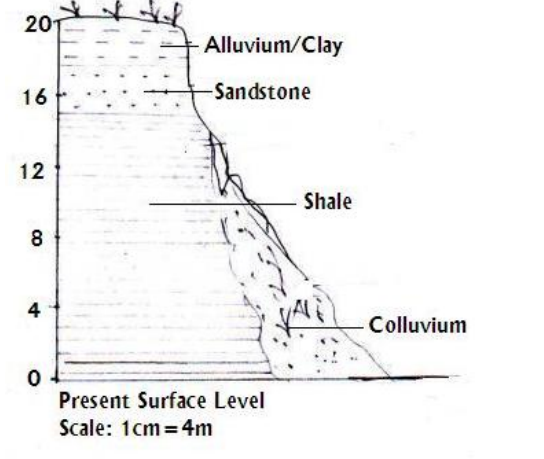
<p>Landslide ID: 70 Location: West Lar Para, Kolatoli Bypass., Cox's Bazar district</p>	<p>Coordinates: N-21°25'35.8" E-91°59'47.0"</p>

<p>Date of Occurrence: 15 June, 2010 and 15 June, 2003.</p>	<p>Landslide History: Initiated movement in June 2003, Subsequently activated in June 2010 (Repetitive).</p>
<p>Rainfall: June 15, 2003: 77 mm during 24 hours and 771mm during 13 days (continuous rain from 3 to 15 June) June 15, 2010:</p>	
<p>Geology: The failed slope is western scarp of a large escarpment with a height of around 25m. The height of the failed part of the slope is around 20m and width is around 50 m. The mountain forming bed rock of the escarpment is formed of mainly two lithological units- lower bluish gray thinly laminated moderately weathered shale unit and upper moderately weathered yellowish brown cross-bedded to massive medium- to fine-grained sandstone and the top part of this unit about 3 m is highly weathered. The failed mass comprised of highly weathered rock and moderately weathered rock. After the slide at places a moderately weathered rock is exposed. The exposed rock units are mostly composed of light brown fine to medium grained sand, silt and clay. The height of the failure surface is around 20 m.</p> <p>Fracturing: Three sets of joints are observed on failure surface of the bed rock and one is parallel to the bedding plane (345/7) and other two are almost vertical and perpendicular to each other (170/85 and 5/88). The joints are filled with weathered clay, silt and fine sand.</p> <p>Overburden Deposits: Total overburden comprised of clay, silt and sand material. The material contains the relic structure of the bed rock which suggests it to be residual soil. The thickness of the residual soil layer which overlays the bed rock mass is around 2 m thick. The thickness of colluvial soil is around 8m.</p>

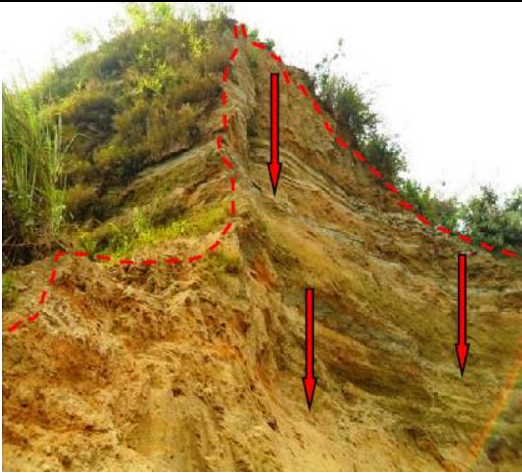
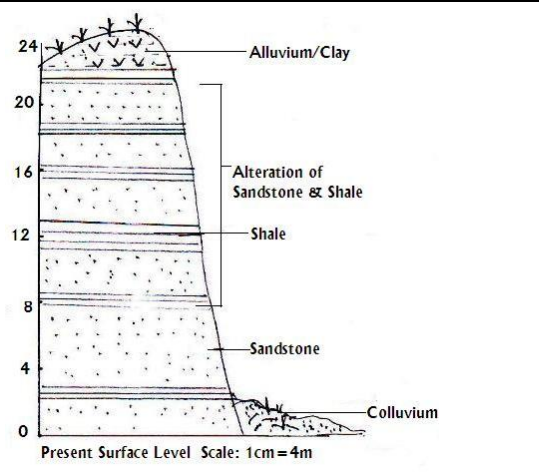
<p>Landslide ID: 80 Location: Lar Para, Kolatoli Bypass., Cox's Bazar district</p>	<p>Coordinates: N-21°25'30.2", E-92°00'10.2"</p>

Date of Occurrence: 15 June, 2010 and 3 July 2008.	Landslide History: Initiated movement in July 2008, Subsequently activated in June 2010.
Rainfall: July 3, 2008: 134 mm during 24 hours and 729mm during 7 days (continuous rain from 27 June to 3 July)	
Geology: The failed slope is north-western scarp of a large escarpment with a height of around 30m. The height of the failed part of the slope is around 24m and width is around 35 m. The mountain forming bed rock of the escarpment is formed of mainly two lithological units- bluish gray thinly

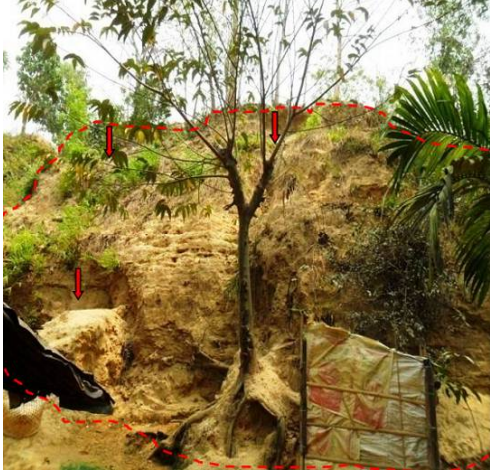
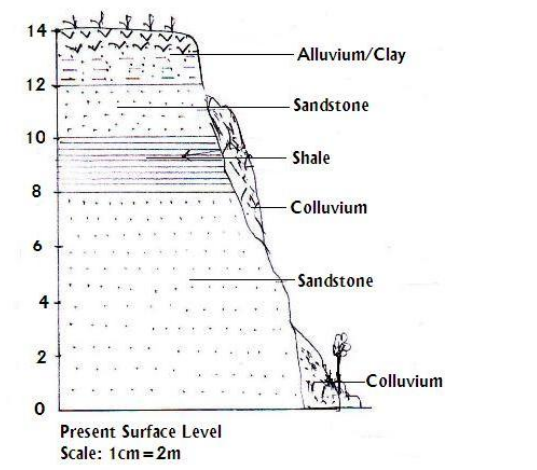
<p>Landslide ID: 86 Location: South Dikkul, Lar Para, Kolatoli Bypass., Cox's Bazar district</p>	<p>Coordinates: N-21°25'17.5", E-92°00'29.1"</p>

<p>Date of Occurrence: July 6, 2008.</p>	<p>Landslide History: Landslide occurred here in July 2008.</p>
<p>Rainfall: 64 mm during 24 hours and 927mm during 10 days (continuous rain from 27 June to 6 July)</p>	
<p>Geology: The failed slope is western scarp of a large escarpment with a height of around 15m. The height of the failed part of the slope is around 12m and width is around 60 m. The mountain forming bed rock of the escarpment is formed of mainly two lithological units: bluish gray thinly laminated shale unit and yellowish brown cross-bedded to massive medium- to fine-grained sandstone. Sandstones comparatively loose and less compact. Top part of this unit about 3.5m is highly weathered. The failed mass comprised of highly weathered rock and moderately weathered rock. After the slide at places a moderately weathered rock is exposed. The exposed rock units are mostly composed of light brown fine to medium grained sand, silt and clay. The height of the failure surface is around 13 m.</p> <p>Fracturing: Three sets of joints are observed on failure surface of the bed rock and one is parallel to the bedding plane (345/7) and other two are almost vertical and perpendicular to each other (350/85 and 185/88). The joints are filled with weathered clay, silt and fine sand.</p> <p>Overburden Deposits: Total overburden comprised of clay, silt and sand material. The material contains the relic structure of the bed rock which suggests it to be residual soil. The soil thickness of the residual soil layer which overlays the bed rock mass is around 1 m thick. The thickness of colluvial soil is around 8m.</p>

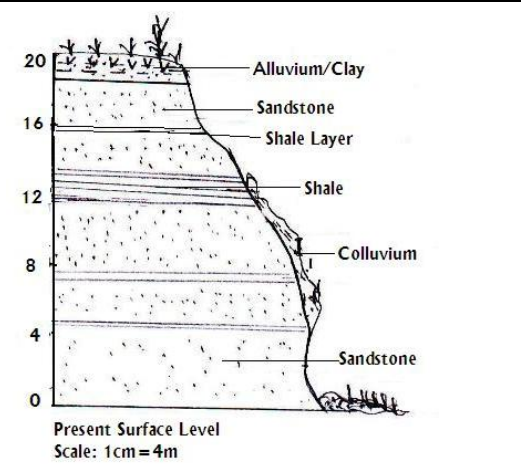
Landslide ID: 87 Location: South Dikkul, Lar Para, Kolatoli Bypass., Cox's Bazar district.	Coordinates: N-21°25'20.4", E- 92°00'27.2"

Date of Occurrence: June 19, 2004 and July 8, 2006.	Landslide History: Initiated movement in June 2004, Subsequently activated in July 2006.
Rainfall: June 19, 2004: 142 mm during 24 hours and 447mm during 4 days (continuous rain from 15 to 19 June) July 8, 2006: 100 mm during 24 hours.	
Geology: The failed slope is south-eastern scarp of a large escarpment with a height of around 24m. The height of the failed part of the slope is around 20m and width is around 40 m. The mountain forming bed rock of the escarpment is formed of mainly two lithological units: bluish gray thinly laminated shale unit and yellowish brown cross-bedded to massive medium- to fine-grained sandstone. Sandstones comparatively loose and less compact. Top part of this section about

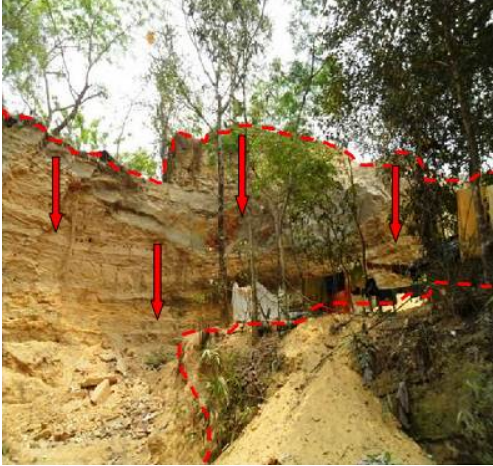
<p>Landslide ID: 90 Location: South Dikkul, Lar Para, Cox's Bazar district.</p>	<p>Coordinates: N-21°25'31.8" E-92°00'25.7"</p>

<p>Date of Occurrence: July 3, 2008.</p>	<p>Landslide History: Subsequently activated in July 2008.</p>
<p>Rainfall: 134 mm during 24 hours and 729mm during 7 days (continuous rain from 27 June to 3 July)</p>	
<p>Geology: The failed slope is western scarp of a large escarpment with a height of around 15m. The height of the failed part of the slope is around 11m and width is around 30 m. The mountain forming bed rock of the escarpment is formed of mainly three lithological units- bluish gray thinly laminated shale unit, dark gray mudstone and yellowish brown cross-bedded to massive medium- to fine-grained sandstone. The failed mass comprised of highly weathered rock and moderately weathered rock. After the slide at places a moderately weathered rock is exposed. The exposed rock units are mostly composed of light brown fine to medium grained sand, silt and clay. The height of the failure surface is around 11 m.</p> <p>Fracturing: Three sets of joints are observed on failure surface of the bed rock and one is parallel to the bedding plane (350/10) and other two are almost vertical and perpendicular to each other (350/80 and 185/85). The joints are filled with weathered clay, silt and fine sand.</p> <p>Overburden Deposits: Total overburden comprised of clay, silt and sand material. The material contains the relic structure of the bed rock which suggests it to be residual soil. The soil thickness of the residual soil layer which overlays the bed rock mass is around 0.5 m thick.</p>

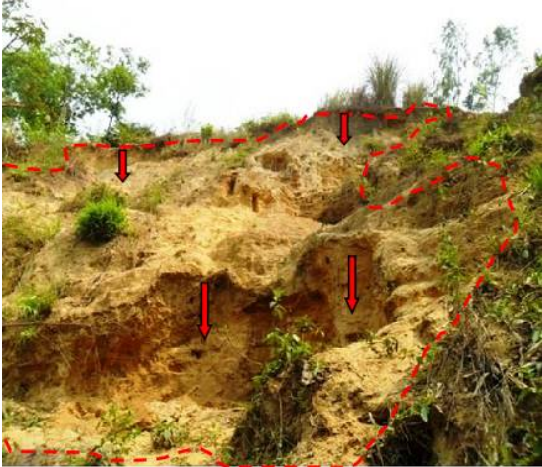
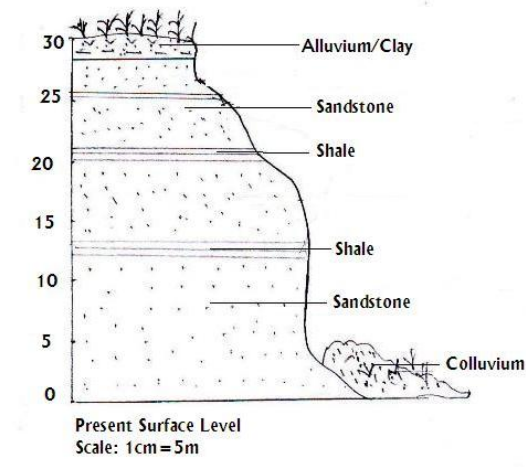
Landslide ID: 93 Location: South Dikkul, Lar Para, Cox's Bazar district	Coordinates: N-21°25'26.2", E-92°00'33.2"

Date of Occurrence: 15 June 2010 and 3 July 2008.	Landslide History: Initiated movement in July 2008, Subsequently activated in June 2010.
Rainfall: July 6, 2008: 64 mm during 24 hours and 927mm during 10 days (continuous rain from 27 June to 6 July)	
Geology: The failed slope is northern scarp of a large escarpment with a height of around 40m. The height of the failed part of the slope is around 30m and width is around 50 m. The mountain forming bed rock of the escarpment is formed of mainly two lithological units- bluish gray thinly laminated shale unit and upper yellowish brown cross-bedded to massive medium- to fine-grained sandstone and the top part of this unit about 4 m is highly weathered. The failed mass comprised of highly weathered rock and moderately weathered rock. After the slide at places a moderately weathered rock is exposed. The exposed rock units are mostly composed of light brown fine to medium grained sand, silt and clay. Sandstones comparatively loose and less compact. The height of the failure surface is around 30 m.

Fracturing: Three sets of joints are observed on failure surface of the bed rock and one is parallel to

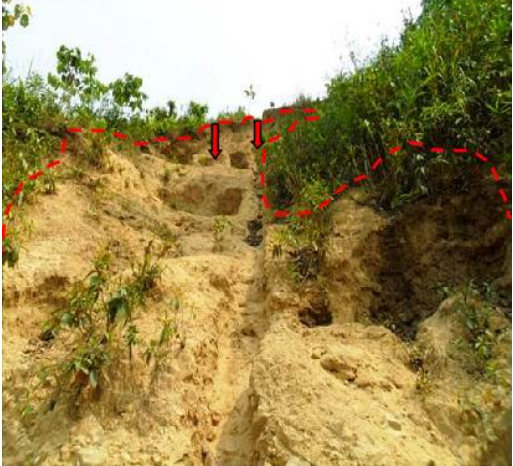
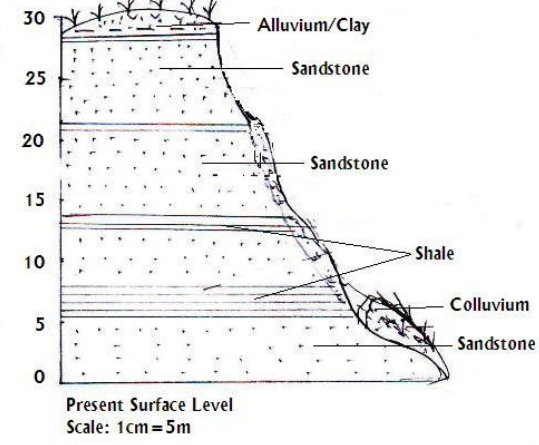
<p>Landslide ID: 95 Location: South Dikkul, Lar Para, Cox's Bazar district</p>	<p>Coordinates: N-21°25'21.1" E-92°00'37.6"</p>

<p>Present Surface Level Scale: 1cm = 5m</p>
<p>Date of Occurrence: 15 June 2010 and July 3, 2008.</p>	<p>Landslide History: Initiated movement in July 2008, Subsequently activated in June 2010.</p>
<p>Rainfall: July 3, 2008: 134 mm during 24 hours and 729mm during 7 days (continuous rain from 27 June to 3 July)</p>	
<p>Geology: The failed slope is north-western scarp of a large escarpment with a height of around 40m. The height of the failed part of the slope is around 30m and width is around 60m. The mountain forming bed rock of the escarpment is dark gray shale but highly to moderately weathered on the surface exposure. The bed rock is thinly laminated and highly weathered in the upper part and lower part is well consolidated. The failed mass comprised of completely weathered rock and highly weathered rock. After the slide at places a moderately weathered rock is exposed. The exposed rock units are mostly composed of light brown silt, clay and fine to medium grained sand. Lithology of this area is mainly Shale and Sandstone. Sandstones comparatively loose and less compact. The height of the failure surface is around 30 m.</p> <p>Fracturing: Three sets of joints are observed on failure surface of the bed rock and one is parallel to the bedding plane (350/10) and other two are almost vertical and perpendicular to each other (350/80 and 185/85). The joints are filled with weathered clay, silt and fine sand.</p> <p>Overburden Deposits: Total overburden comprised of clay, silt and sand material. The material contains the relic structure of the bed rock which suggests it to be residual soil. The soil thickness of the residual soil layer which overlays the bed rock mass is around 2m thick</p>

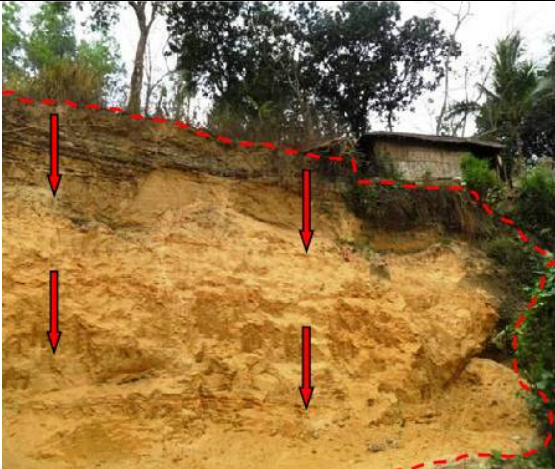
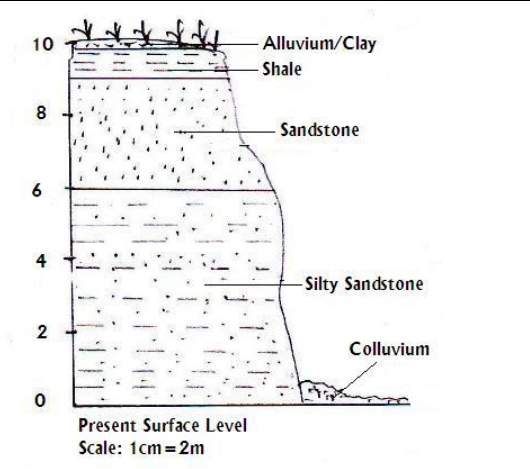
Landslide ID: 97 Location: South Haji Para, Cox's Bazar district	Coordinates: N-21°25'26.6" E-92°00'40.0"

Date of Occurrence: 15 June 2010 and 10 June 2006.	Landslide History: Initiated movement in June 2006, Subsequently activated in June 2010.
Rainfall: June 10, 2006: 113 mm during 24 hours and 477mm during 7 days (continuous rain from 4 to 10 June).	
Geology: The failed slope is eastern scarp of a large escarpment with a height of around 12m. The height of the failed part of the slope is around 10m and width is around 30m. The mountain forming bed rock of the escarpment is formed of mainly two lithological units- bluish gray thinly laminated moderately weathered shale unit and moderately weathered yellowish brown cross-bedded to massive medium- to fine-grained sandstone and the top part of this unit about 1 m is highly weathered. The failed mass comprised of highly weathered rock and moderately weathered rock. After the slide at places a moderately weathered rock is exposed. The exposed rock units are mostly composed of light brown fine to medium grained sand, silt and clay. Sandstones comparatively loose and lower portion comprises of clayey silt materials. The height of the failure surface is around 10 m.

Fracturing: Three sets of joints are observed on failure surface of the bed rock and one is parallel to

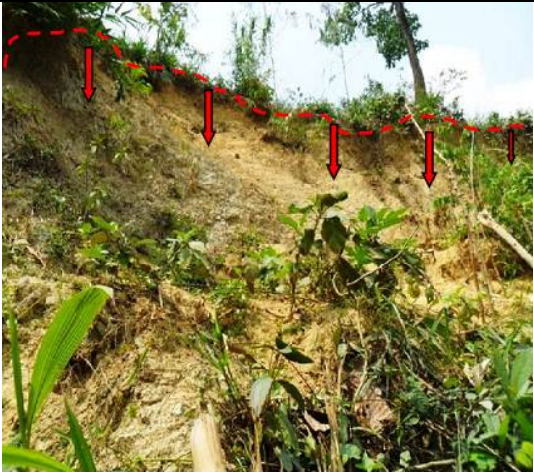
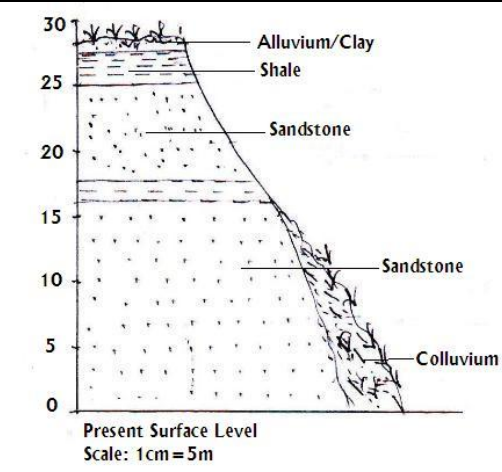
Landslide ID: 98 Location: South Haji Para, Cox's Bazar district		Coordinates: N-21°25'21.3" E-92°00'38.7"

Date of Occurrence: 15 June 2010 and June 19, 2004.		Landslide History: Initiated movement in June 2004, Subsequently activated in June 2010.	
Rainfall: June 19, 2004: 142 mm during 24 hours and 447mm during 4 days (continuous rain from 15 to 19 June)			
<p>Geology: The failed slope is northern scarp of a large escarpment with a height of around 30m. The height of the failed part of the slope is around 28m and width is around 40m. The mountain forming bed rock of the escarpment is formed of mainly two lithological units- bluish gray thinly laminated shale unit and yellowish brown cross-bedded to massive medium- to fine-grained sandstone and the top part of this section about 3 m is highly weathered. The failed mass comprised of highly weathered rock and moderately weathered rock. After the slide at places a moderately weathered rock is exposed. The exposed rock units are mostly composed of light brown fine to medium grained sand, silt and clay. Sandstones comparatively loose and less compact. The height of the failure surface is around 28 m.</p> <p>Fracturing: Three sets of joints are observed on failure surface of the bed rock and one is parallel to the bedding plane (350/10) and other two are almost vertical and perpendicular to each other (350/80 and 185/85). The joints are filled with weathered clay, silt and fine sand.</p> <p>Overburden Deposits: Total overburden comprised of clay, silt and sand material. The material contains the relic structure of the bed rock which suggests it to be residual soil. The soil thickness of the residual soil layer which overlays the bed rock mass is around 1 m thick. The residual soil thickness is about 1m and colluviums soil is about 11m.</p>

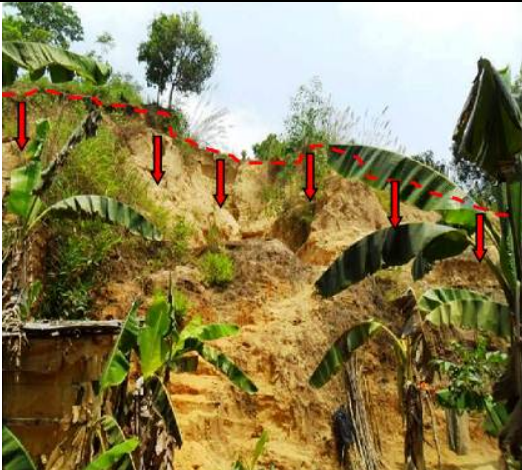
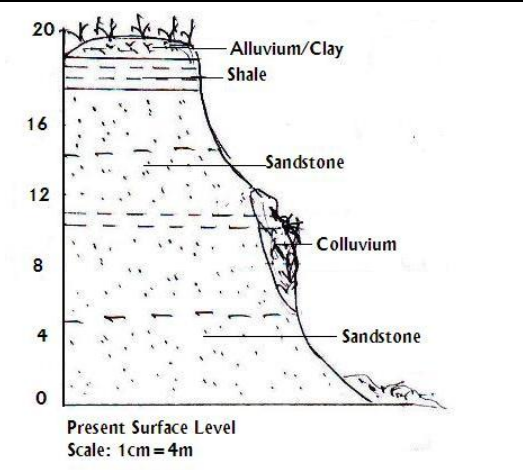
<p>Landslide ID: 99 Location: South Haji Para, Cox's Bazar district</p>	<p>Coordinates: N-21°25'18.4" E-92°00'39.9"</p>

<p>Date of Occurrence: 15 June 2010 and July 3, 2008.</p>	<p>Landslide History: Initiated movement in July 2008, Subsequently activated in June 2010.</p>
<p>Rainfall: July 3, 2008: 134 mm during 24 hours and 729mm during 7 days (continuous rain from 27 June to 3 July)</p>	
<p>Geology: The failed slope is southern scarp of a large escarpment with a height of around 25m. The height of the failed part of the slope is around 21m and width is around 30m. The mountain forming bed rock of the escarpment is formed of mainly two lithological units- bluish gray thinly laminated shale unit and yellowish brown cross-bedded to massive medium- to fine-grained sandstone. Top part of this section about 2.5 m is highly weathered. The failed mass comprised of highly weathered rock and moderately weathered rock. After the slide at places a</p>

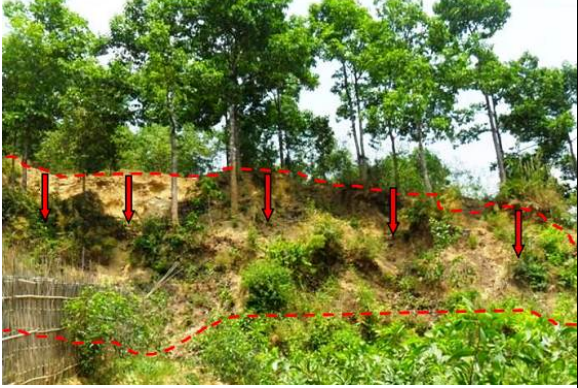
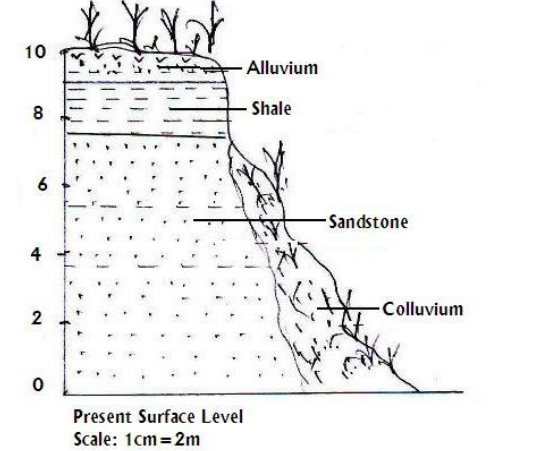
<p>Date of Occurrence: 14 June 2010 Rainfall:</p>	<p>Landslide History: Subsequently activated in June 2010.</p>
<p>Geology: The failed slope is southern scarp of a large escarpment with a height of around 12m. The height of the failed part of the slope is around 10m and width is around 30m. The mountain forming bed rock of the escarpment is formed of mainly two lithological units- bluish gray thinly laminated shale unit and yellowish brown cross-bedded to massive medium- to fine-grained sandstone. Top part of this section about 3 m is highly weathered. The failed mass comprised of highly weathered rock and moderately weathered rock. After the slide at places a moderately weathered rock is exposed. Sandstones comparatively loose and less compact. The exposed rock units are mostly composed of light brown fine to medium grained sand, silt and clay. The height of the failure surface is around 10 m.</p> <p>Fracturing: Three sets of joints are observed on failure surface of the bed rock and one is parallel to the bedding plane (350/10) and other two are almost vertical and perpendicular to each other (350/80 and 185/85). The joints are filled with weathered clay, silt and fine sand.</p> <p>Overburden Deposits: Total overburden comprised of clay, silt and sand material. The material contains the relic structure of the bed rock which suggests it to be residual soil. The soil thickness of the residual soil layer which overlays the bed rock mass is around 1 m thick.</p>

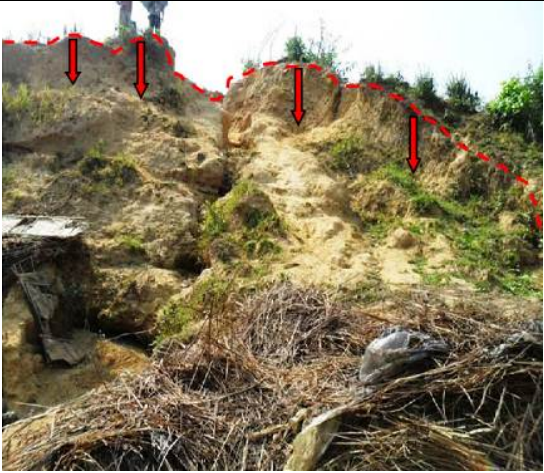
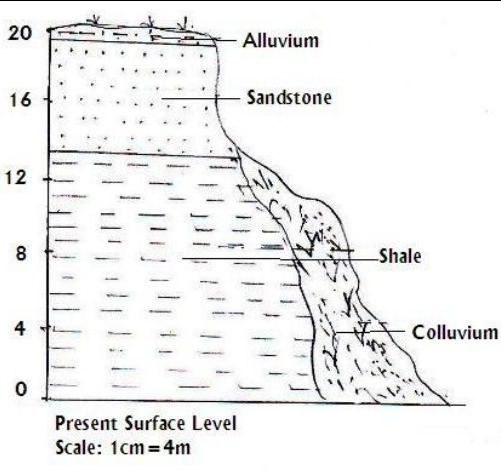
<p>Date of Occurrence: 15 June 2010 Rainfall:</p>	<p>Landslide History: Subsequently activated in June 2010.</p>
<p>Geology: The failed slope is north-western scarp of a large escarpment with a height of around 25m. The height of the failed part of the slope is around 20m and width is around 30m. The mountain forming bed rock of the escarpment is formed of mainly two lithological units- lower bluish gray thinly laminated moderately weathered shale unit and upper moderately weathered yellowish brown cross-bedded to massive medium- to fine-grained sandstone. Top part of this unit about 2 m is highly weathered. The failed mass comprised of highly weathered rock and moderately weathered rock. After the slide at places a moderately weathered rock is exposed. The exposed rock units are mostly composed of light brown fine to medium grained sand, silt and clay. The height of the failure surface is around 20 m.</p>

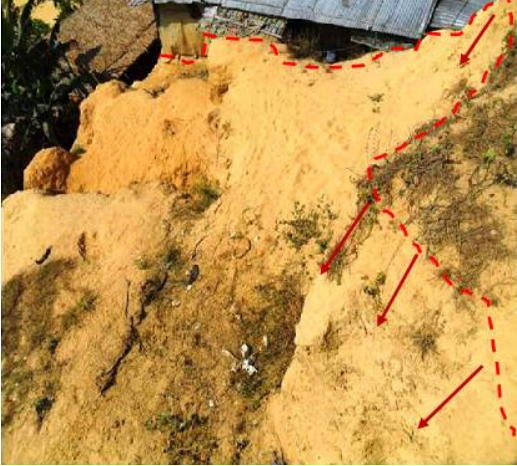
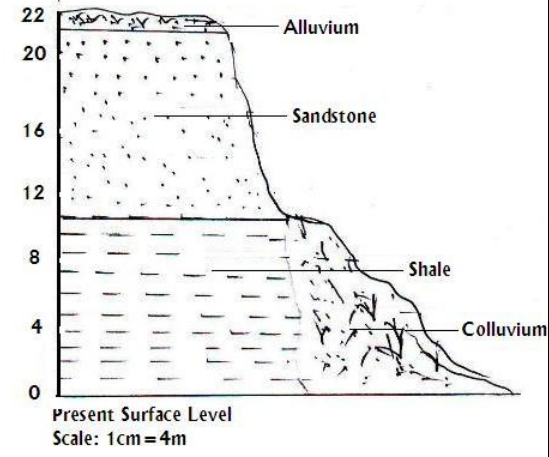
<p>Date of Occurrence: 15 June 2010 Rainfall:</p>	<p>Landslide History: Subsequently activated in June 2010.</p>
<p>Geology: The failed slope is southern scarp of a large escarpment with a height of around 25m. The height of the failed part of the slope is around 22m and width is around 35m. The mountain forming bed rock of the escarpment is dark gray shale but highly to moderately weathered on the surface exposure. The bed rock is thickly laminated and moderately weathered in the upper part and lower part is well consolidated. The failed mass comprised of highly weathered rock. After the slide at places a moderately weathered rock is exposed. The exposed rock units are mostly composed of light brown silt, clay and fine to medium grained sand. Lithology of this area is mainly Shale and Sandstone. Sandstones comparatively loose and less compact. The height of the failure surface is around 22 m.</p> <p>Fracturing: Three sets of joints are observed on failure surface of the bed rock and one is parallel to the bedding plane (340/5) and other two are almost vertical and perpendicular to each other (250/89 and 70/89). The joints are filled with weathered clay, silt and fine sand.</p> <p>Overburden Deposits: Total overburden comprised of clay, silt and sand material. The material contains the relic structure of the bed rock which suggests it to be residual soil. The residual soil thickness is about 1m and colluviul soil is about 10m.</p>

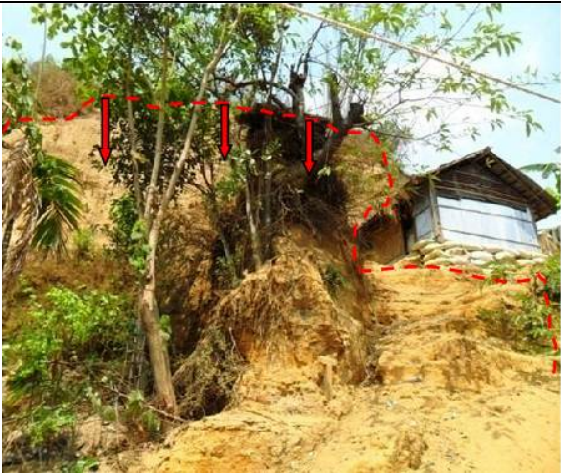
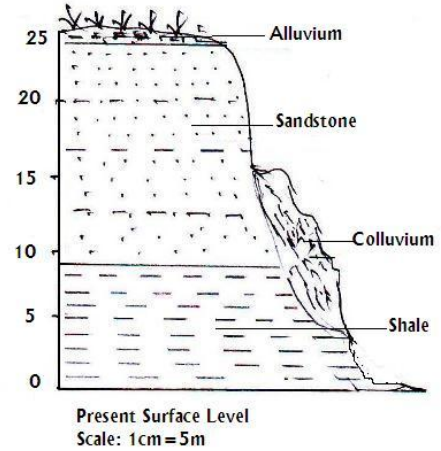
<p>Date of Occurrence: 15 June 2010 and June 11, 2007.</p>	<p>Landslide History: Initiated movement in June 2007, Subsequently activated in June 2010.</p>
<p>Rainfall: June 11, 2007: 101 mm during 24 hours and 240mm during 7 days (continuous rain from 4 to 11 June)</p>	
<p>Geology: The failed slope is eastern scarp of a large escarpment with a height of around 30m. The height of the failed part of the slope is around 25m and width is around 40m. The mountain forming bed rock of the escarpment is formed of mainly two lithological units- lower bluish gray thinly laminated moderately weathered shale unit and upper moderately weathered yellowish brown cross-bedded to massive medium- to fine-grained sandstone. Top part of this section about 3 m is highly weathered. The failed mass comprised of highly weathered rock and moderately weathered rock. After the slide at places a moderately weathered rock is exposed. The exposed rock units are mostly composed of light brown fine to medium grained sand, silt and clay. Sandstones comparatively loose and less compact. The height of the failure surface is around 25 m.</p>

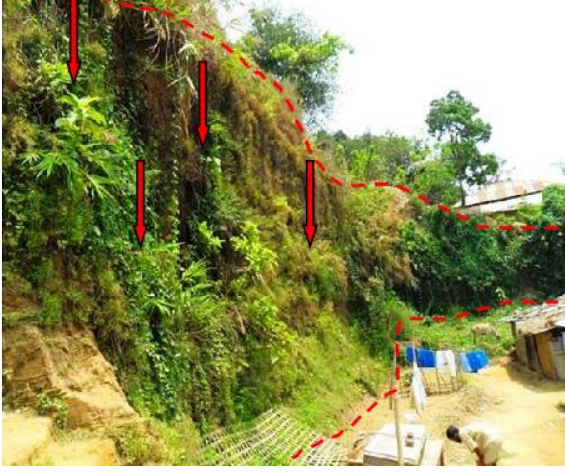
<p>Date of Occurrence: 15 June 2010 Rainfall:</p>	<p>Landslide History: Subsequently activated in June 2010.</p>
<p>Geology: The failed slope is south-western scarp of a large escarpment with a height of around 12m. The height of the failed part of the slope is around 10m and width is around 40m. The mountain forming bed rock of the escarpment is formed of mainly two lithological units- lower bluish gray thinly laminated moderately weathered shale unit and upper moderately weathered yellowish brown cross-bedded to massive medium- to fine-grained sandstone and the top part of this unit about 3 m is highly weathered. The failed mass comprised of highly weathered rock and moderately weathered rock. After the slide at places a moderately weathered rock is exposed. The exposed rock units are mostly composed of light brown fine to medium grained sand, silt and clay. The height of the failure surface is around 10 m.</p> <p>Fracturing: Three sets of joints are observed on failure surface of the bed rock and one is parallel to the bedding plane (340/15) and other two are almost vertical and perpendicular to each other (160/89 and 70/85). The joints are filled with weathered clay, silt and fine sand.</p> <p>Overburden Deposits: Total overburden comprised of clay, silt and sand material. The material contains the relic structure of the bed rock which suggests it to be residual soil. The soil thickness of the residual soil layer which overlays the bed rock mass is around 1 m thick.</p>

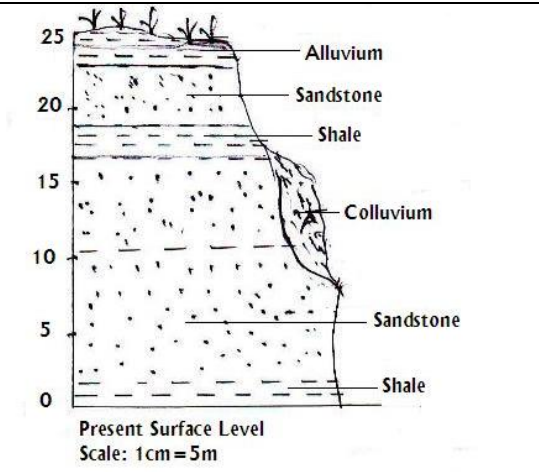
Date of Occurrence: 15 June 2010 and July 3, 2008.	Landslide History: Initiated movement in July 2008, Subsequently activated in June 2010.
Rainfall: July 3, 2008: 134 mm during 24 hours and 729mm during 7 days (continuous rain from 27 June to 3 July)	
Geology: The failed slope is northern scarp of a large escarpment with a height of around 30m. The height of the failed part of the slope is around 25m and width is around 40m. The mountain forming bed rock of the escarpment is formed of mainly two lithological units- bluish gray thinly laminated moderately weathered shale unit and upper moderately weathered yellowish brown cross-bedded to massive medium- to fine-grained sandstone and the top part of this unit about 3.5 m is highly weathered. The failed mass comprised of highly weathered rock and moderately weathered rock. After the slide at places a moderately weathered rock is exposed. The exposed rock units are mostly composed of light brown fine to medium grained sand, silt and clay. Sandstones comparatively loose and less compact. The height of the failure surface is around 25 m.

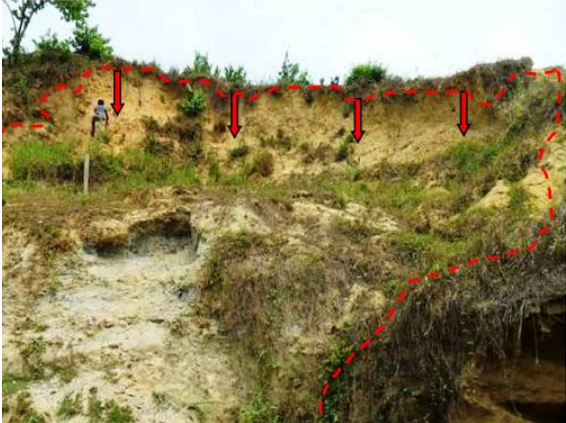
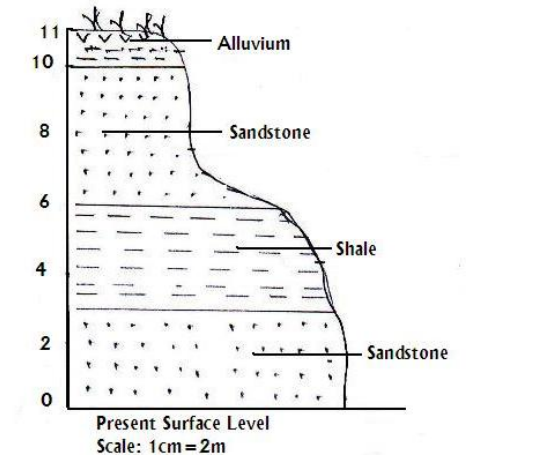
<p>Date of Occurrence: 15 June 2010 and June 11, 2007.</p>	<p>Landslide History: Initiated movement in June 2007, Subsequently activated in June 2010.</p>
<p>Rainfall: June 11, 2007: 101 mm during 24 hours and 240mm during 7 days (continuous rain from 4 to 11 June)</p>	
<p>Geology: The failed slope is eastern scarp of a large escarpment with a height of around 20m. The height of the failed part of the slope is around 11m and width is around 40m. The mountain forming bed rock of the escarpment is formed of mainly two lithological units- bluish gray thinly laminated moderately weathered shale unit and moderately weathered yellowish brown cross-bedded to massive medium- to fine-grained sandstone and the top part of this unit about 4 m is highly weathered. The failed mass comprised of highly weathered rock and moderately weathered rock. After the slide at places a moderately weathered rock is exposed. The exposed rock units are mostly composed of light brown fine to medium grained sand, silt and clay. The height of the failure surface is around 11 m.</p> <p>Fracturing: Three sets of joints are observed on failure surface of the bed rock and one is parallel to the bedding plane (340/15) and other two are almost vertical and perpendicular to each other (160/89 and 70/85). The joints are filled with weathered clay, silt and fine sand.</p> <p>Overburden Deposits: Total overburden comprised of clay, silt and sand material. The material contains the relic structure of the bed rock which suggests it to be residual soil. The soil thickness of the residual soil layer which overlays the bed rock mass is around 1 m thick.</p>

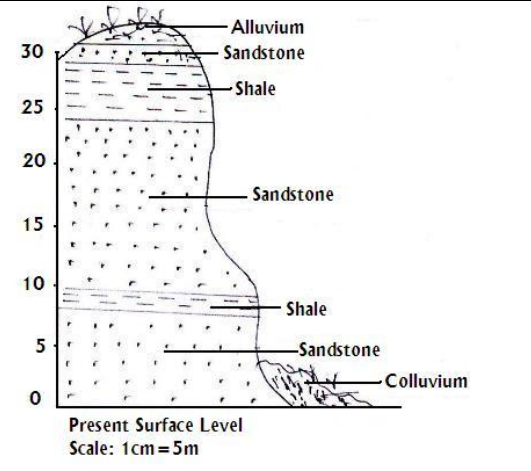
<p>Present Surface Level Scale: 1cm = 5m</p>
Date of Occurrence: 15 June 2010 Rainfall:	Landslide History: Subsequently activated in June 2010.
Geology: The failed slope is southern scarp of a large escarpment with a height of around 32m. The height of the failed part of the slope is around 29m and width is around 60m. The mountain forming bed rock of the escarpment is formed of mainly two lithological units- bluish gray thinly laminated moderately weathered shale unit and moderately weathered yellowish brown cross-bedded to massive medium- to fine-grained sandstone and the top part of this unit about 2.5 m is highly weathered. The failed mass comprised of highly weathered rock and moderately weathered

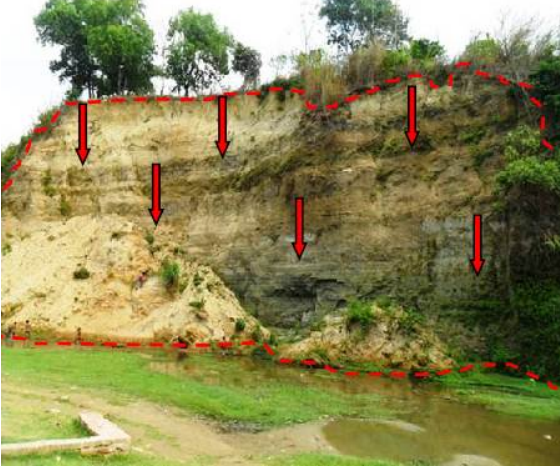
<p>Date of Occurrence: 15 June 2010 Rainfall:</p>	<p>Landslide History: Subsequently activated in June 2010.</p>
<p>Geology: The failed slope is southern scarp of a large escarpment with a height of around 25m. The height of the failed part of the slope is around 25m and width is around 120m. The mountain forming bed rock of the escarpment is formed of mainly two lithological units- bluish gray thinly laminated moderately weathered shale unit and moderately weathered yellowish brown cross-bedded to massive medium- to fine-grained sandstone and the top part of this unit about 3 m is highly weathered. The failed mass comprised of highly weathered rock and moderately weathered rock. After the slide at places a moderately weathered rock is exposed. The exposed rock units are mostly composed of light brown fine to medium grained sand, silt and clay. The height of the failure surface is around 25 m.</p> <p>Fracturing: Three sets of joints are observed on failure surface of the bed rock and one is parallel to the bedding plane (345/5) and other two are almost vertical and perpendicular to each other (260/70 and 100/89). The joints are filled with weathered clay, silt and fine sand.</p> <p>Overburden Deposits: Total overburden comprised of clay, silt and sand material. The material contains the relic structure of the bed rock which suggests it to be residual soil. The soil thickness of the residual soil layer which overlays the bed rock mass is around 1.5m thick. The colluvial soil thickness is about 8m.</p>

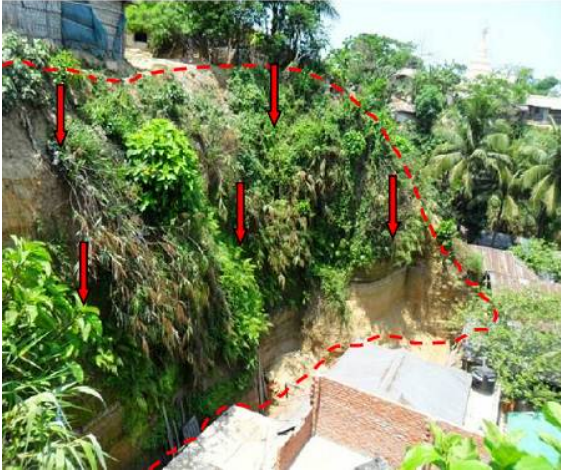
Date of Occurrence: 15 June 2010 and July 3, 2008.	Landslide History: Initiated movement in July 2008, Subsequently activated in June 2010.
Rainfall: July 3, 2008: 134 mm during 24 hours and 729mm during 7 days (continuous rain from 27 June to 3 July)	
Geology: The failed slope is northern scarp of a large escarpment with a height of around 30m. The height of the failed part of the slope is around 20m and width is around 40m. The mountain forming bed rock of the escarpment is formed of mainly two lithological units- bluish gray thinly laminated moderately weathered shale unit and moderately weathered yellowish brown cross-bedded to massive medium- to fine-grained sandstone and the top part of this unit about 3 m is highly weathered. The failed mass comprised of highly weathered rock and moderately weathered rock. After the slide at places a moderately weathered rock is exposed. The exposed rock units are mostly composed of light brown fine to medium grained sand, silt and clay. The height of the failure surface is around 20 m.

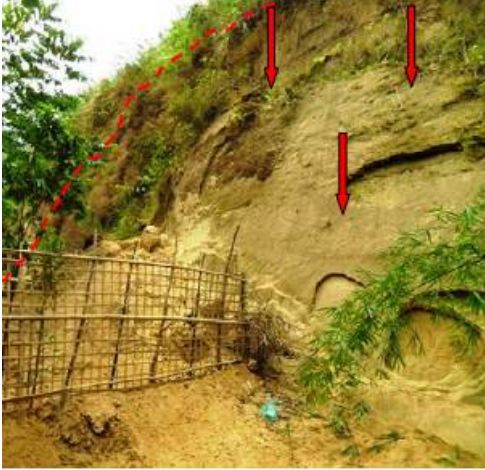
<p>Date of Occurrence: June 15, 2010 and July 6, 2008</p>	<p>Landslide History: Initiated movement in July 2008, Subsequently activated in June 2010 .</p>
<p>Rainfall: July 6, 2008: 209 mm during 24 hours and 1332mm during 12 days (continuous rain from 25 June to 6 July)</p>	
<p>Geology: The failed slope is north-eastern scarp of a large escarpment with a height of around 35m. The height of the failed part of the slope is around 30m and width is around 50 m. The mountain forming bed rock of the escarpment is formed of mainly two lithological units- lower bluish gray thinly laminated moderately weathered shale unit and upper moderately weathered yellowish brown cross-bedded to massive medium- to fine-grained sandstone and the top part of this unit about 3.5 m is highly weathered. The failed mass comprised of highly weathered rock and moderately weathered rock. After the slide at places a moderately weathered rock is exposed. The exposed rock units are mostly composed of light brown fine to medium grained sand, silt and clay. The sandstone rock is massive and poorly consolidated in the upper part and lower part is well consolidated. The height of the failure surface is around 30 m.</p> <p>Fracturing: Three sets of joints are observed on failure surface of the bed rock and one is parallel to the bedding plane (115/78) and other two are almost vertical and perpendicular to each other (205/89 and 92/4). The joints are filled with weathered clay, silt and fine sand.</p> <p>Overburden Deposits: Total overburden comprised of clay sand material. The material contains the relic structure of the bed rock which suggests it to be residual soil. The soil thickness of the residual soil layer which overlays the bed rock is around 1 m thick. The colluvial soil thickness is around 8m.</p>

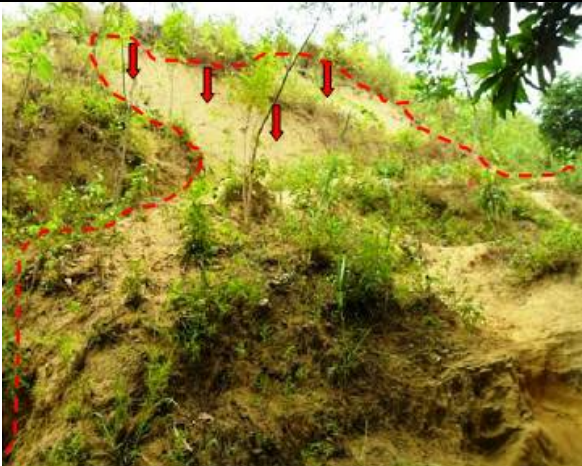
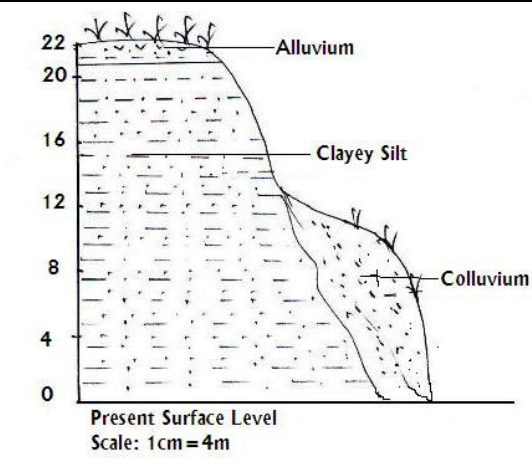
Date of Occurrence: June 15, 2010 Rainfall:	Landslide History: Subsequently activated in June 2010.
Geology: The failed slope is north-eastern scarp of a large escarpment with a height of around 30m. The height of the failed part of the slope is around 22m and width is around 30 m. The mountain forming bed rock of the escarpment is formed of mainly moderately weathered yellowish brown clayey silt and the top part of this unit about 4 m is highly weathered. The failed mass comprised of highly weathered rock and moderately weathered rock. After the slide at places a

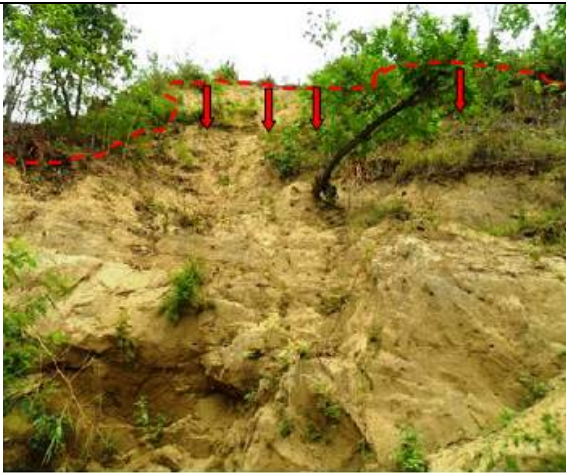
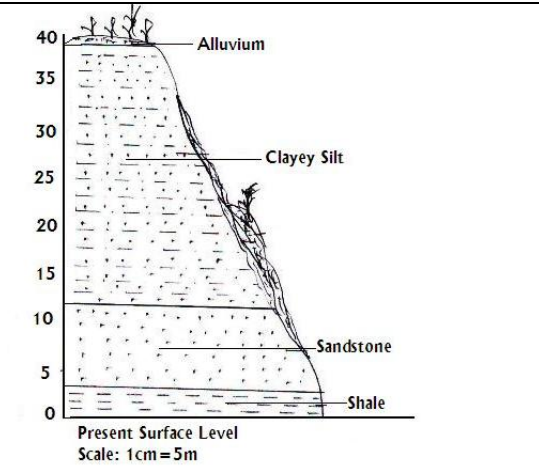
Date of Occurrence: June 15, 2010	Landslide History: Subsequently activated in June 2010.
Rainfall:	
<p>Geology: The failed slope is south-western scarp of a large escarpment with a height of around 45m. The height of the failed part of the slope is around 40m and width is around 60 m. The mountain forming bed rock of the escarpment is formed of mainly three lithological units- bluish</p>

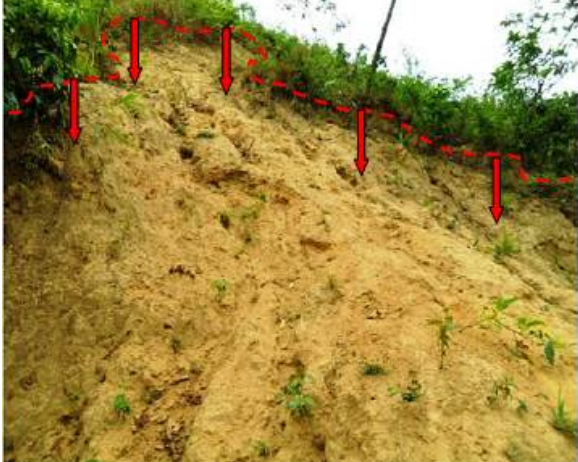
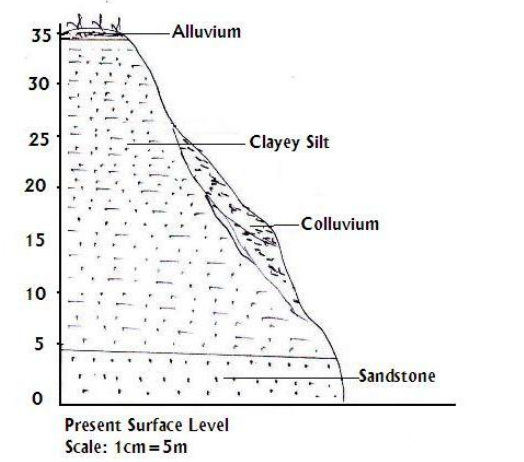
<p>Date of Occurrence: July 6, 2008.</p>	<p>Landslide History: Subsequently activated in July 2008.</p>
<p>Rainfall: 209 mm during 24 hours and 1332mm during 12 days (continuous rain from 25 June to 6 July)</p>	
<p>Geology: The failed slope is north-eastern scarp of a large escarpment with a height of around 40m. The height of the failed part of the slope is around 35m and width is around 50 m. The mountain forming bed rock of the escarpment is formed of mainly two lithological units-yellowish brown cross-bedded to massive medium- to fine-grained sandstone and light yellowish color clayey silt. Top part of this unit about 5 m is highly weathered. The failed mass comprised of highly weathered rock and moderately weathered rock. After the slide at places a moderately weathered rock is exposed. The exposed rock units are mostly composed of light brown fine to medium grained sand, silt and clay. The height of the failure surface is around 35 m.</p> <p>Fracturing: Sets of joints are not observed on failure surface of the bed rock.</p> <p>Overburden Deposits: Total overburden comprised of clay, silt and fine sand. The material contains the relic structure of the bed rock which suggests it to be residual soil. The soil thickness of the residual soil layer which overlays the bed rock mass is around 1 m thick. Colluvial soil is about 15m.</p>

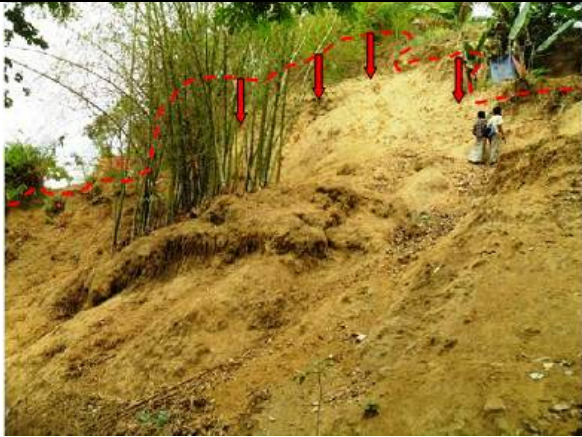
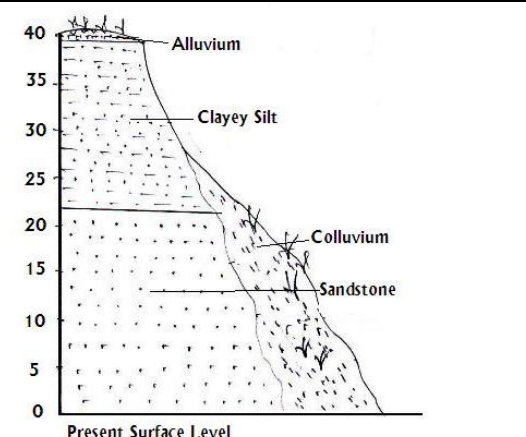
<p>Date of Occurrence: July 6, 2008.</p>	<p>Landslide History: Subsequently activated in July 2008.</p>
<p>Rainfall: 209 mm during 24 hours and 1332mm during 12 days (continuous rain from 25 June to 6 July)</p>	
<p>Geology: The failed slope is north-eastern scarp of a large escarpment with a height of around 40m. The height of the failed part of the slope is around 35m and width is around 50 m. The mountain forming bed rock of the escarpment is formed of mainly two lithological units- yellowish brown cross-bedded to massive medium- to fine-grained sandstone and light yellowish color clayey silt. Top part of this unit about 5 m is highly weathered. The sandstone rock is massive and poorly consolidated in the upper part and lower part is well consolidated. The failed mass comprised of completely weathered rock and highly weathered rock. After the slide at places a moderately weathered rock is exposed. The height of the failure surface is around 35 m.</p> <p>Fracturing: Sets of joints are not observed on failure surface of the bed rock.</p> <p>Overburden Deposits: Total overburden comprised of clay, silt and fine sand. The material contains the relic structure of the bed rock which suggests it to be residual soil. The soil thickness of the residual soil layer which overlays the bed rock mass is around 1 m thick. Colluvial soil is about 10m.</p>

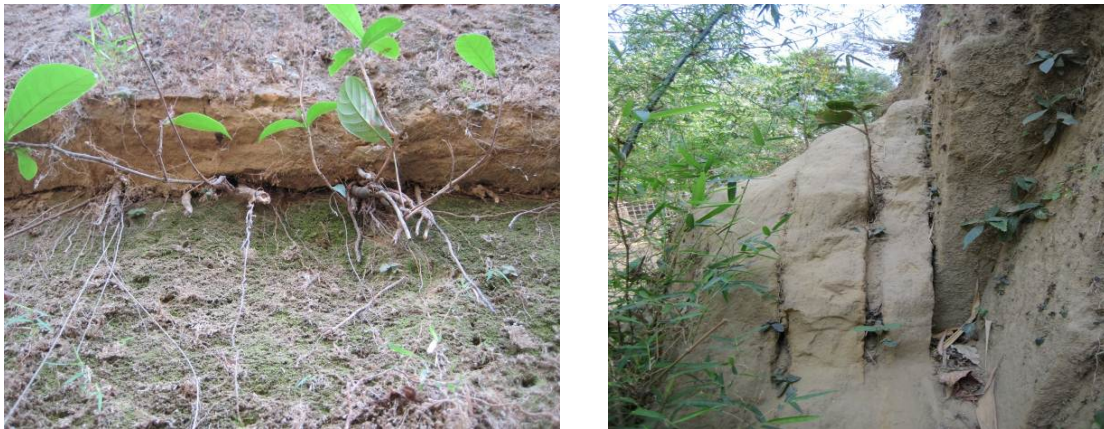
Plate 3: Root systems developed in joints and in think inter-bedded layers
