LANDSLIDE INVENTORY AND LAND-USE MAPPING, DEM PREPARATION, PRECIPITATION THRESHOLD VALUE AND ESTABLISHMENT OF EARLY WARNING DEVICES

March 2012

Rainfall Triggered Landslide Hazard Zonation in Cox's Bazar & Teknaf Municipalities as well as Introducing Community-based Early Warning System for Landslide Hazard Management

Revised Report on Landslide Inventory and Land-use Mapping, DEM Preparation, Precipitation Threshold Value & Establishment of Early Warning Devices

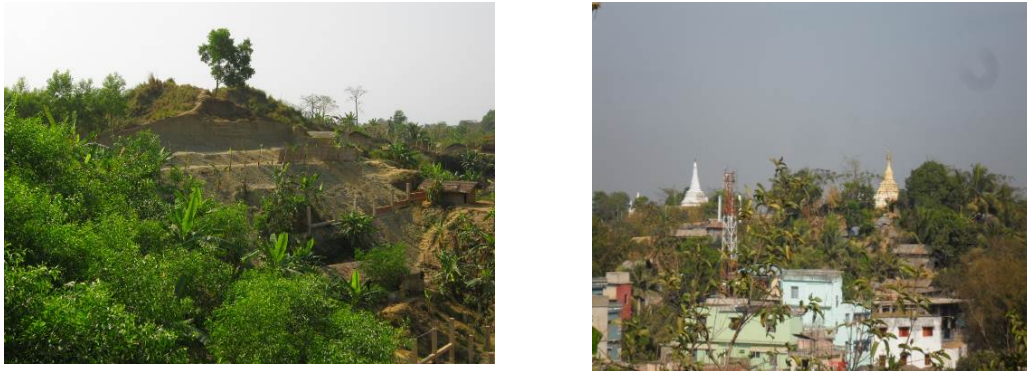
Plate 5: Various types of excavations done by communities on slopes for cultivation purposes and settlements on hill slopes
