LANDSLIDE INVENTORY AND LAND-USE MAPPING, DEM PREPARATION, PRECIPITATION THRESHOLD VALUE AND ESTABLISHMENT OF EARLY WARNING DEVICES

March 2012

Rainfall Triggered Landslide Hazard Zonation in Cox's Bazar & Teknaf Municipalities as well as Introducing Community-based Early Warning System for Landslide Hazard Management

Revised Report on Landslide Inventory and Land-use Mapping, DEM Preparation, Precipitation Threshold Value & Establishment of Early Warning Devices

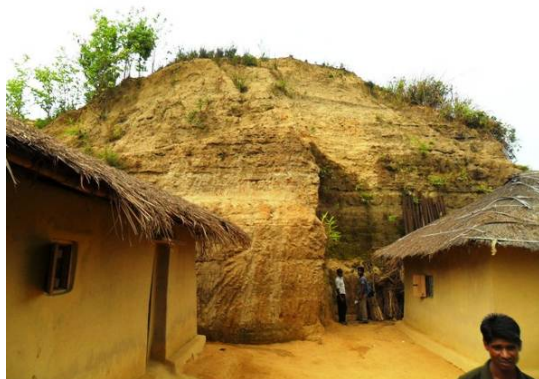
Vulnerable Houses at East Pahartoli

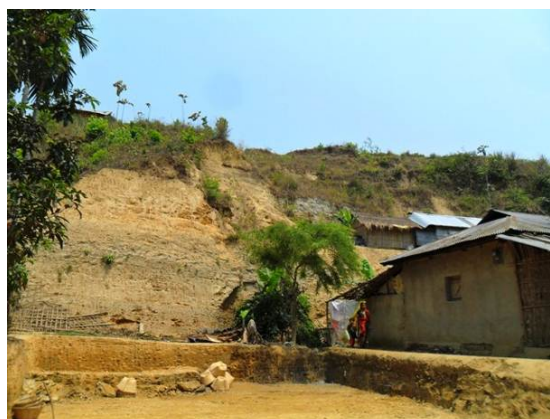
Vulnerable Houses at West Lar Para

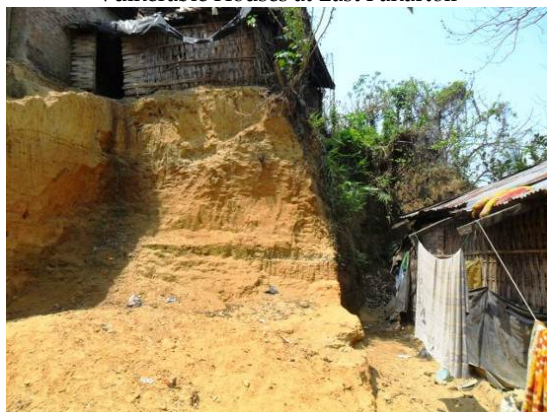
Vulnerable houses at Mohajer para

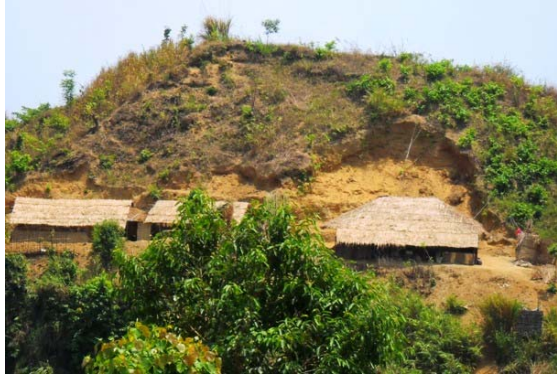
Houses at Hillside of Kolatolii

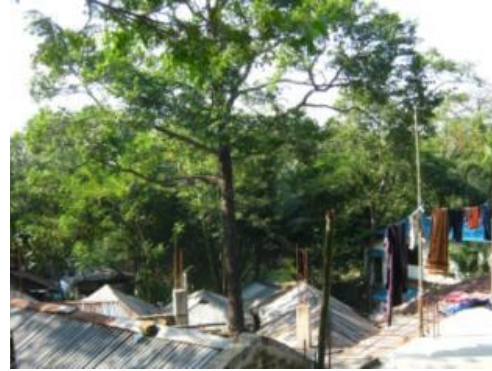
Houses vulnerable to Landslide-Mohajer para

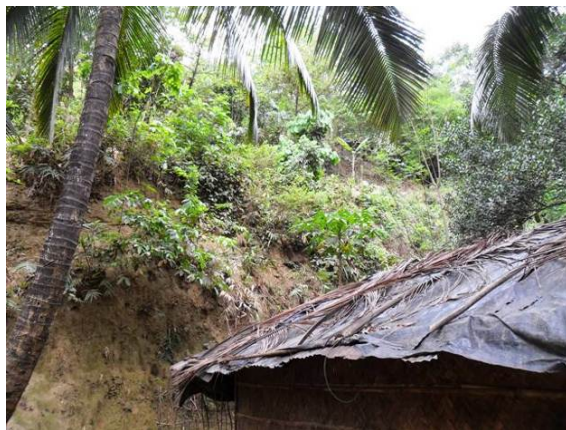
Houses near landslide site at Urumer Chara

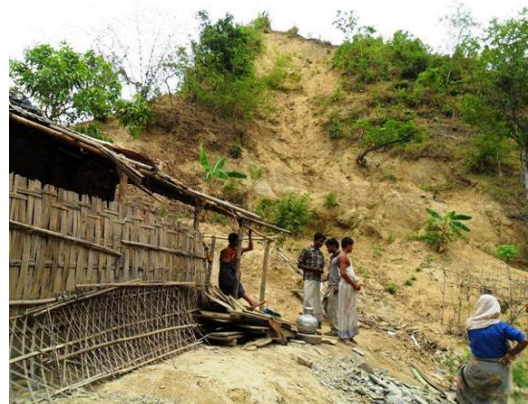
Houses Located near the Landslide site at Puran Pallan Para

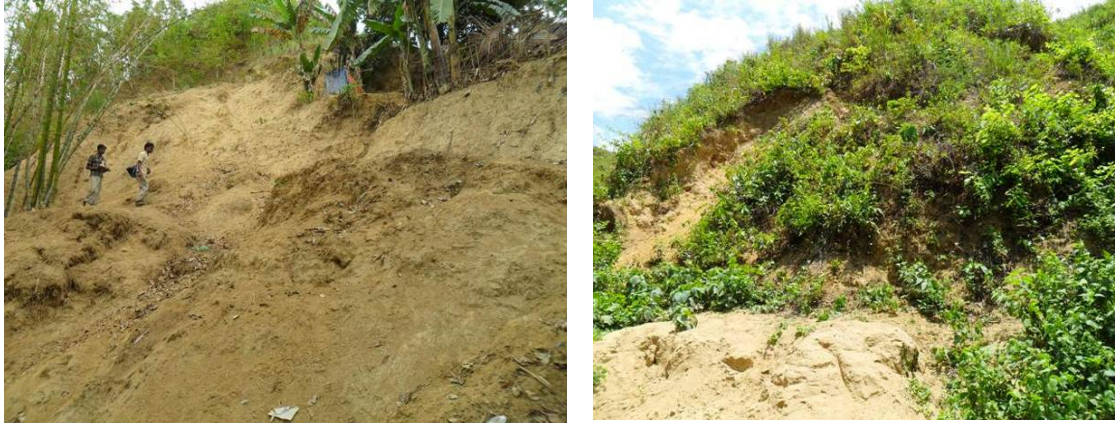
Landslide Sites at Puran Pallan Para

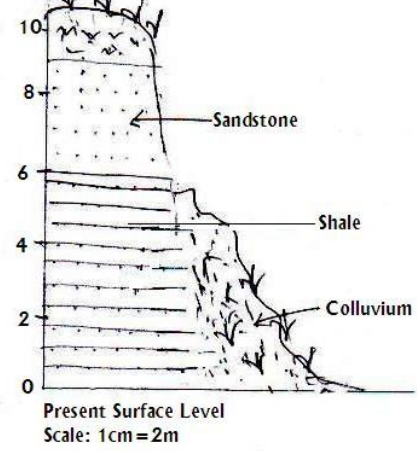
<p>Landslide ID: 09 Location: South Ganar Ghona, Cox's Bazar district</p>	<p>Coordinates: N-21°25'00.5", E-92°01'04.6"</p>

<p>Present Surface Level Scale: 1cm = 2m</p>
<p>Date of Occurrence: 15 June 2010, 3 July 2008 and 11 June 2007. (The Landslide Occurred around 6:00am due to heavy rain.</p>	<p>Landslide History: Initiated movement in June 2007, Subsequently activated in July 2008 and June 2010.</p>
<p>Rainfall: June 11, 2007: 101 mm during 24 hours and 240mm during 7 days (continuous rain from 4 to 11 June). July 3, 2008: 134 mm during 24 hours and 729mm during 7 days (continuous rain from 27 June to 3 July). June 15, 2010:</p>	
<p>Geology: The failed slope is western scarp of a large escarpment with a height of around 15m. The height of the failed part of the slope is around 12m and width is around 60 m. The mountain forming bed rock of the escarpment is formed of mainly two lithological units- lower bluish gray thinly laminated moderately weathered shale unit and upper moderately weathered yellowish brown cross-bedded to massive medium- to fine-grained sandstone and the top part of this unit about 3 m is highly weathered. The failed mass comprised of highly weathered rock and moderately weathered rock. After the slide at places a moderately weathered rock is exposed. The exposed rock units are mostly composed of light brown fine to medium grained sand, silt and clay. The height of the failure surface is around 12 m.</p> <p>Fracturing: Three sets of joints are observed on failure surface of the bed rock and one is parallel to the bedding plane (158/15) and other two are almost vertical and perpendicular to each other (260/85 and 100/89). The joints are filled with weathered clay, silt and fine sand.</p> <p>Overburden Deposits: Total overburden comprised of clay, silt and sand material. The material contains the relic structure of the bed rock which suggests it to be residual soil. The soil thickness of the residual soil layer which overlays the bed rock mass is around 1 m thick. The thickness of colluvial soil is around 4m.</p>

<p>Slope Characteristics</p>	<p>The escarpment slope is near vertical and the upper part consists of highly weathered bed rock. Lower part consists of thinly laminated shale. Light brown color fine to medium grained sand which is about 3m in thickness present above the shale layer.</p> <p>The failed mass is a part of the near vertical escarpment and the debris moved from the slope is underlain by the talus material, which seems to</p>

Impact of the landslide	<p>No major impacts. Only a small portion of the hill got destroyed completely</p>
Future Risks	<p>In future this sliding can get repeated as there is a possibility of destabilization of the mass above the slope. The impact would be further destruction to the hill and garden.</p> <p>In the down slope around 50m away several human settlements are located and down slope movement of debris flow can create impact to houses and also people living there. The risk is moderate to high.</p>

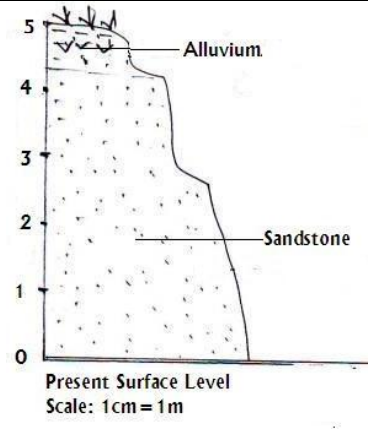
<p>Landslide ID: 21</p> <p>Location: South Ganar Ghona, Cox's Bazar district</p>	<p>Coordinates: N-21°25'02.2", E-92°00'54.9"</p>

Date of Occurrence: 15 June 2010. The Landslide Occurred around 5:00am due to heavy rain.		Landslide History: Landslide occurred here in June 2010.	
<p>Geology: The height of failed part of the slope is around 5m and width is around 20m. The exposed rock units are mostly composed of light brown silt, and fine to medium grained sand; locally contains debris derived from local bedrock. Lithology of this area is mainly Sand. The bed rock is massive and loose sediments in the upper part and lower part is well consolidated. The failed mass comprised of completely weathered rock and highly weathered rock. After the slide at places a moderately weathered rock is exposed. The height of the failure surface is around 5m.</p> <p>Fracturing: Sets of joints are not observed on failure surface of the rock.</p> <p>Overburden Deposits: Total overburden comprised of clay, silt and fine sand materials. The material contains the relic structure of the bed rock which suggests it to be residual soil. The soil thickness of the residual soil layer which overlays the bed rock mass is around 1m thick.</p>

Slope Characteristics	The escarpment slope is near vertical to incline and the upper part consists of highly to moderately weathered rock. Lower part consists of fine to medium grained sand and it is comparatively slightly weathered.		
Land use	This area completely affected by human intervention. Several houses there. Some part of this area is used for gardening.		
Hydrology	No natural drainage path is visible in the area of the landslide and area is dry.		
Landslide Mechanism	The recent history shows that the excessive rainfall is the main triggering factor of the slide which can be described as "debris flow". The slide has been reactivated several times during monsoon period.		
Impact of the landslide	One house in front of this hill got destroyed completely.		
Future Risks	In future this sliding can get repeated as there is a possibility of destabilization of the mass above the slope. The impact would be further destruction to the house and garden. The risk is moderate to low.

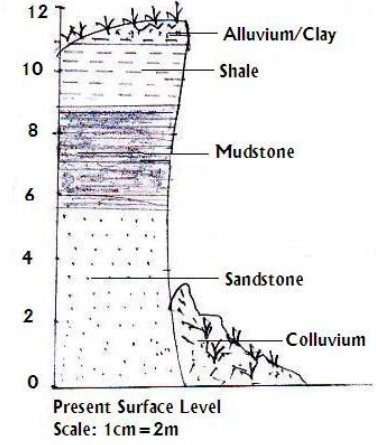
<p>Landslide ID: 90 Location: South Dikkul, Lar Para, Cox's Bazar district.</p>	<p>Coordinates: N-21°25'31.8" E-92°00'25.7"</p>

<p>Date of Occurrence: July 3, 2008.</p>	<p>Landslide History: Subsequently activated in July 2008.</p>
<p>Rainfall: 134 mm during 24 hours and 729mm during 7 days (continuous rain from 27 June to 3 July)</p>	
<p>Geology: The failed slope is western scarp of a large escarpment with a height of around 15m. The height of the failed part of the slope is around 11m and width is around 30 m. The mountain forming bed rock of the escarpment is formed of mainly three lithological units- bluish gray thinly laminated shale unit, dark gray mudstone and yellowish brown cross-bedded to massive medium- to fine-grained sandstone. The failed mass comprised of highly weathered rock and moderately weathered rock. After the slide at places a moderately weathered rock is exposed. The exposed rock units are mostly composed of light brown fine to medium grained sand, silt and clay. The height of the failure surface is around 11 m.</p> <p>Fracturing: Three sets of joints are observed on failure surface of the bed rock and one is parallel to the bedding plane (350/10) and other two are almost vertical and perpendicular to each other (350/80 and 185/85). The joints are filled with weathered clay, silt and fine sand.</p> <p>Overburden Deposits: Total overburden comprised of clay, silt and sand material. The material contains the relic structure of the bed rock which suggests it to be residual soil. The soil thickness of the residual soil layer which overlays the bed rock mass is around 0.5 m thick.</p>

<p>Slope Characteristics</p>	<p>The escarpment slope is vertical and the upper part consists of highly weathered bed rock (clay type rock). Original slope 36°. Middle part consists of thick mudstone layer. Lower part consists of fine to medium grained sand. Soil mass accumulated against the slope. Thickness is around 2m.</p>
<p>Land use</p>	<p>The area is mainly used for human settlements. There are more than 2 houses and more than 15 people live in this area. Some part of this area used for gardening.</p>
<p>Hydrology</p>	<p>No natural drainage path is visible in the area of the landslide and area is dry.</p>
<p>Landslide Mechanism</p>	<p>The recent history shows that the excessive rainfall is the main triggering factor of the slide which can be described as "debris flow". The slide has been activated in June 2009 during monsoon period. The following can be postulated about the mechanisms.</p>

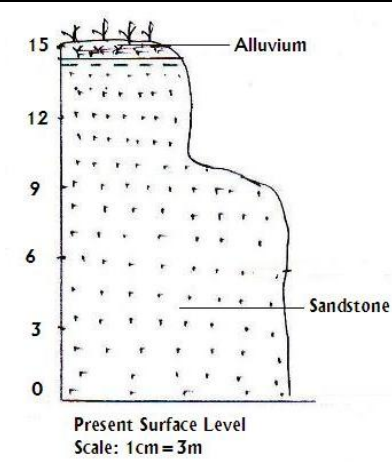
Landslide ID: 112 Location: Pahartoli, Cox's Bazar district		Coordinates: N-21°26'8.2" E-91°58'57.1"

Date of Occurrence: 15 June 2010 Rainfall:		Landslide History: Subsequently activated in June 2010.	
<p>Geology: The failed slope is north-western scarp of a large escarpment with a height of around 20m. The height of the failed part of the slope is around 15m and width is around 30m. The mountain forming bed rock of the escarpment is formed of mainly moderately weathered yellowish brown cross-bedded to massive medium- to fine-grained sandstone and the top part of this unit about 3 m is highly weathered. The failed mass comprised of highly weathered rock and moderately weathered rock. After the slide at places a moderately weathered rock is exposed. The exposed rock units are mostly composed of light brown fine to medium grained sand, silt and clay. Sandstones comparatively loose and less compact. The height of the failure surface is around 15 m.</p> <p>Fracturing: Sets of joints are not observed on failure surface of the bed rock.</p> <p>Overburden Deposits: Total overburden comprised of clay, silt and sand material. The material contains the relic structure of the bed rock which suggests it to be residual soil. The soil thickness of the residual soil layer which overlays the bed rock mass is around 1 m thick.</p>

Slope Characteristics		The escarpment slope is near vertical and the upper part consists of highly weathered bed rock. Lower part consists of fine to medium grained sand. Original slope 32°. The failed mass is a part of the upper portion.	
Land use		The area is mainly used for human residence. There are more than 6 houses and more than 25 people live in this area. Some part of this area is used for gardening.	
Hydrology		No natural drainage path is visible in the area of the landslide and area is dry.	
Landslide Mechanism		The recent history shows that the excessive rainfall is the main triggering factor of the slide which can be described as "debris flow". The slide has been activated during monsoon period.	
Impact of the landslide		Have major impacts. One house got destroyed completely during June 2010 landslide.	
Future Risks		In future this sliding can get repeated as there is a possibility of destabilization of the mass above the slope. The impact would be further destruction to the hill. In the down slope around 10m away the human residence is located

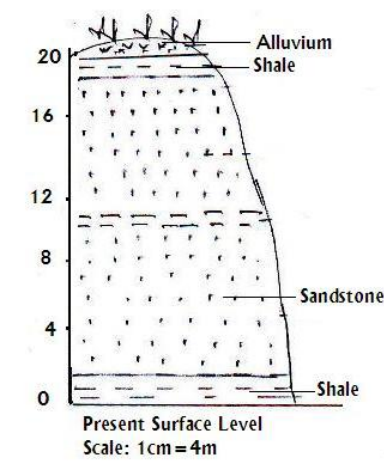
Landslide ID: 143 Location: Baidder Ghuna, Cox's Bazar district	Coordinates: N-21°26'16.9" E-91°58'54.6"

Date of Occurrence: 15 June 2010 and July 3, 2008.	Landslide History: Initiated movement in July 2008, Subsequently activated in June 2010.
Rainfall: July 3, 2008: 134 mm during 24 hours and 729mm during 7 days (continuous rain from 27 June to 3 July)	
Geology: The failed slope is northern scarp of a large escarpment with a height of around 30m. The height of the failed part of the slope is around 20m and width is around 40m. The mountain forming bed rock of the escarpment is formed of mainly two lithological units- bluish gray thinly laminated moderately weathered shale unit and moderately weathered yellowish brown cross-bedded to massive medium- to fine-grained sandstone and the top part of this unit about 3 m is highly weathered. The failed mass comprised of highly weathered rock and moderately weathered rock. After the slide at places a moderately weathered rock is exposed. The exposed rock units are mostly composed of light brown fine to medium grained sand, silt and clay. The height of the failure surface is around 20 m.

Fracturing: Three sets of joints are observed on failure surface of the bed rock and one is parallel to the bedding plane (340/5) and other two are almost vertical and perpendicular to each other (250/89 and 70/89). The joints are filled with weathered clay, silt and fine sand.	
Overburden Deposits: Total overburden comprised of clay, silt and sand material. The material

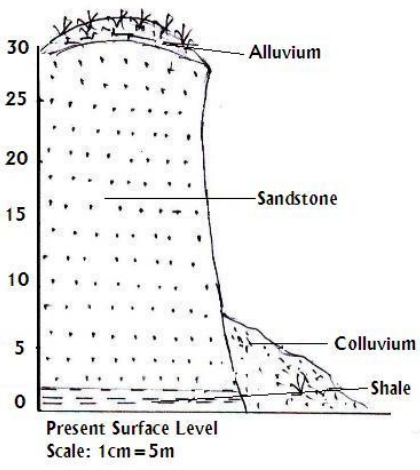
<p>Landslide ID: 03 Location: Fakirer Mura, Puran Pallan Para, Teknaf Municipal Area</p>	<p>Coordinates: N-20°52'21.4" E-92°17'34.2"</p>

<p>Date of Occurrence: June 15, 2010 and July 6, 2008</p>	<p>Landslide History: Initiated movement in July 2008, Subsequently activated in June 2010 .</p>
<p>Rainfall: July 6, 2008: 209 mm during 24 hours and 1332mm during 12 days (continuous rain from 25 June to 6 July)</p>	
<p>Geology: The failed slope is north-eastern scarp of a large escarpment with a height of around 35m. The height of the failed part of the slope is around 30m and width is around 50 m. The mountain forming bed rock of the escarpment is formed of mainly two lithological units- lower bluish gray thinly laminated moderately weathered shale unit and upper moderately weathered yellowish brown cross-bedded to massive medium- to fine-grained sandstone and the top part of this unit about 3.5 m is highly weathered. The failed mass comprised of highly weathered rock and moderately weathered rock. After the slide at places a moderately weathered rock is exposed. The exposed rock units are mostly composed of light brown fine to medium grained sand, silt and clay. The sandstone rock is massive and poorly consolidated in the upper part and lower part is well consolidated. The height of the failure surface is around 30 m.</p> <p>Fracturing: Three sets of joints are observed on failure surface of the bed rock and one is parallel to the bedding plane (115/78) and other two are almost vertical and perpendicular to each other (205/89 and 92/4). The joints are filled with weathered clay, silt and fine sand.</p> <p>Overburden Deposits: Total overburden comprised of clay sand material. The material contains the relic structure of the bed rock which suggests it to be residual soil. The soil thickness of the residual soil layer which overlays the bed rock is around 1 m thick. The colluvial soil thickness is around 8m.</p>

<p>Slope Characteristics</p>	<p>The escarpment slope is near vertical and the upper part consists of highly weathered bed rock. Lower part consists of fine to medium grained sand.</p> <p>The original slope of the hill is about 48°. The upper part consists of highly weathered clay type rock. Lower part consists of sand and shale mass. The failed mass is a part of the near vertical escarpment and the debris moved from the slope is underlain by the talus material, which seems to be the remnants of previous landslides.</p> <p>The failed mass is a part of the upper portion. Thickness is around 8 meters.</p>
<p>Land use</p>	<p>This area completely affected by human intervention. There are 4 houses and about 24 people live there. Some part used for gardening.</p>

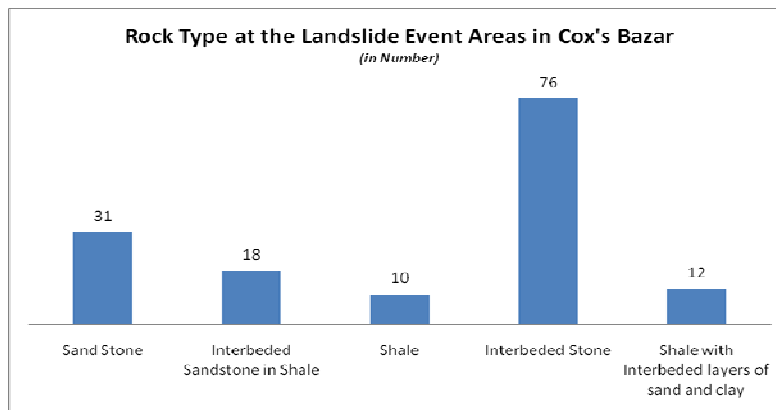
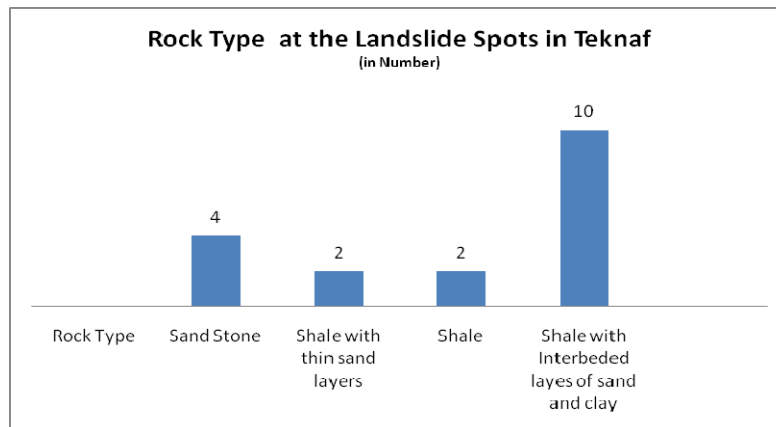
Geology attributes

It is seen from the past landslide Inventory that there are 4-5 categories of rock types observed on the failed slopes but predominant rock types to be shale and sandstones. All other rock types are variations of the same with thinner inter-bedding and presently highly to completely weathered. It is seen that all such main Rock types also are subjected to weathering to a different degree or covered with a Residual soil layer where the relic structure was intact .In certain cases it have had a colluviums layer that has been accumulated on the slope, which overlay the weathered bed rock layer or the residual soil layer. Since the mapping has been carried out several months in some cases year or more, it is difficult to establish the proper boundaries or to postulate the situation within the failure mass. However it is evident that the major impact in destabilizing the slope is due to inter-bedding of clay and sand layers in predominant rock types of Shale and Sandstone weathering penetrated along the thinner layers to a greater depth. Apparently these inter-bedded layers are result of weathering along the bedding plane which usually occurs in a near horizontal angle. Combination of weathering along bedding planes and two fracture zones observed in the area are influencing the detachment of rock mass from the main bed rock and tend to destabilize under gravity. It is easy to have water saturation along such layers and interplay of several joints with bedding plane always create wedge failures or down slope movement of blocks. However since majority of the layer is in highly weathered condition or covered with residual soil or weathered colluviums now we see it as a mass dislocation containing a mixture of rock and soil so it is imperative to see such movements as Debris flows. The vegetation (*see Plate:03*) also play a major role in destabilization of such mass as root systems developed in whether thin layers can help expansion of joint systems as well as bedding planes which help water penetration deep in to rock mass which always increases the potential of failure.

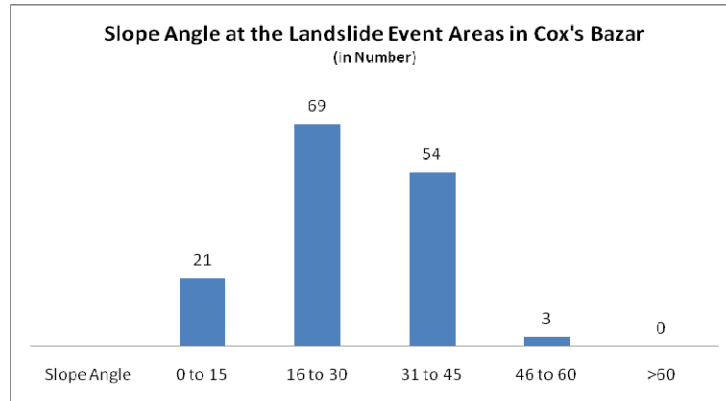
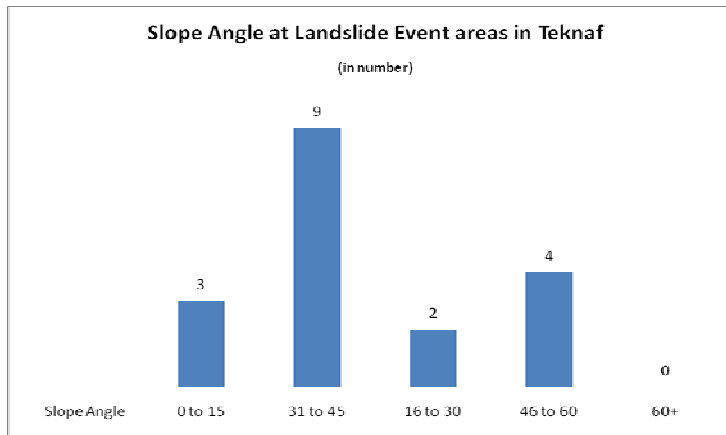
Geo-morphology and slope category attributes

The project team has taken an attempt to analyse the slope angles of failed slopes to see whether any dominance could be seen in the various slope angles. From the evidence of the past landslides it is seen that the most dominant category among failed slopes is the slopes between slope angle of 16-30. Similar correlation can be seen in both municipality areas. The other dominant category is the slopes with slope angle of 31-45. The slopes with slope angle of 45 or less than 15 are less dominant among failed slope categories. The other factor evident from the past landslides is the fact that when the slope angle increases number of landslides in slopes higher than 45 becomes less. It is mainly due to the fact that, when the slope becomes higher the probability of retention of any weaker layer or soil mass is becoming less and under gravity such slopes tend to get eroded systematically. So the retained mass thickness will not be so high and such slopes probably will not fail easily. In certain cases apparently there are block failures which have been occurred along near vertical joints along escarpment slopes elsewhere but such failures have not been seen as the dominant failure mode within the two target cities.

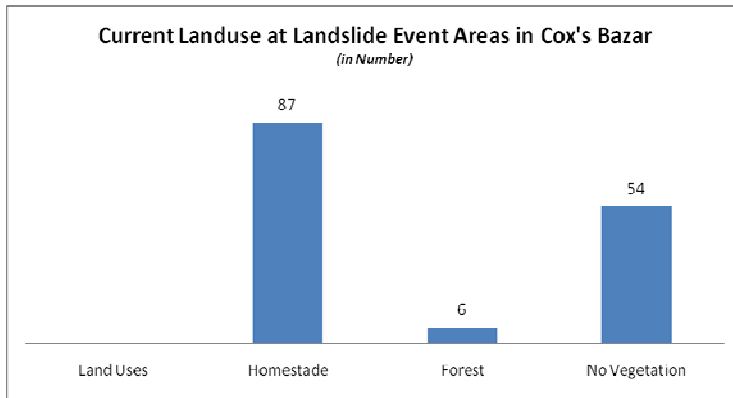
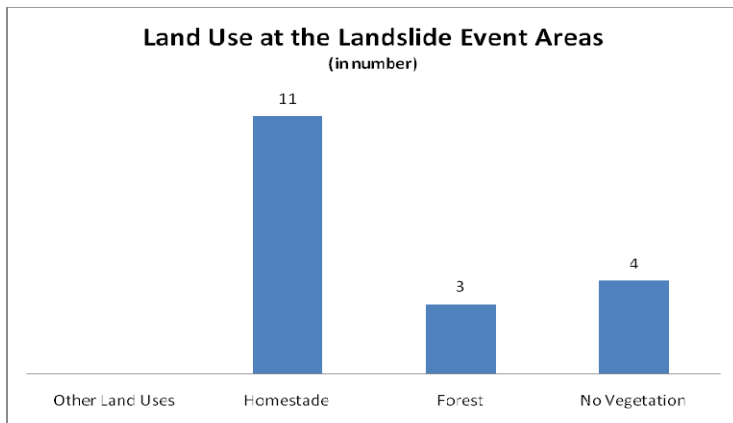
Plate 4: Land use attributes

The project team has observed several land use classes in the area subjected to mapping in two target municipalities. However the dominant land use classes seen in failed slopes are either abandoned land after cultivation or land covered with homesteads. This is seen as major reason for death of people as near settlements always communities used to grow vegetables; fruit trees such as banana on slopes and such land use practices are responsible for destabilization of slopes. The abandoned slopes also are previously used land for

cultivation of vegetables; lentils etc and absence of vegetation cover increased the water percolation which increases the potential for destabilization. Many types of human activities caused disturbances to natural slope such as cultivation, removal of earth for construction purposes, excavations etc. The human settlement areas are mainly subjected to land sliding due to such human interventions (*pl. see Plate 05*). Thick forests areas have not been subjected to landslides and however partially forested areas were subjected to landslides.

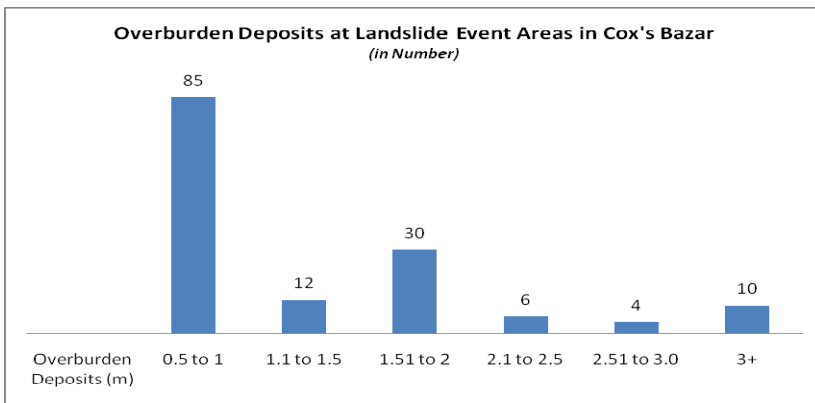
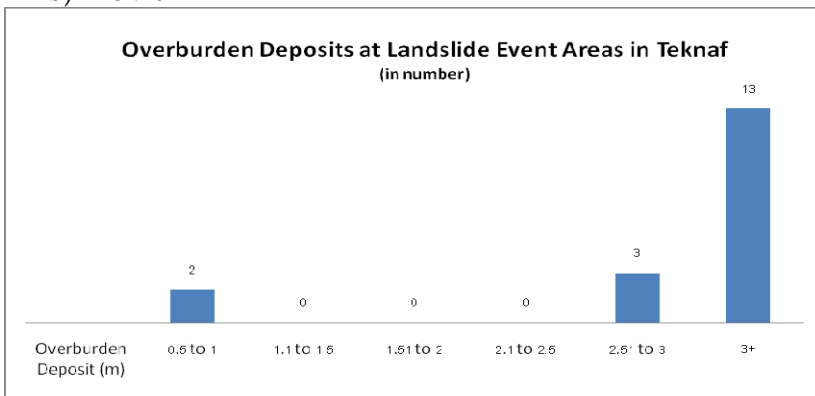
Attributes of Overburden deposits

Overburden deposits usually are consists of colluviums, residual soil and completely weathered rock. In certain cases weathering penetrated highly in to rock mass and thick overburden has failed under gravity. It is seen from the past landslides thicker the overburden tendency for failure becomes also higher. Communities used to stay in areas closer to thick overburden layer as it can be used for cultivation purposes but such slopes also have seen as most vulnerable slopes for landslides.

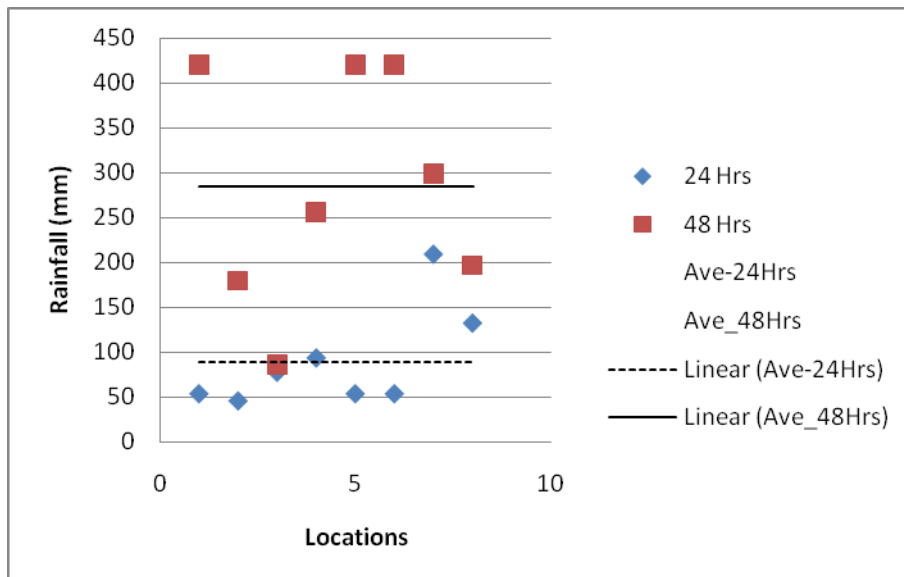
Figure 9: 24 Hrs and 48 Hrs rainfall data before landslides in Cox's Bazaar and Teknaf

This gives around 130mm during 24 hrs rainfall or 300mm rainfall during 48 hrs rainfall could cause a landslide in Cox's Bazaar and Teknaf. However, globally the last night rain causes landslides to occur in the early morning. Then, the day before could also be considered as 24 hrs rainfall and in that case, rainfall would be 170mm/24 hrs. This value exactly fits with Corominas and Moya (1999) values defined for Spain and Brand et al. (1988) values for Hong Kong. Further, it also has some close relationship with Bandara (2008) findings in Sri Lanka for an evacuation warning. However, if hourly rainfall could be found, it would be a supporting data for a better prediction.

Data from Cox's Bazaar gives around 96mm during 24 hrs rainfall or 185mm rainfall during 48 hrs rainfall could cause a landslide. However, the day before could also be considered as 24 hrs rainfall and in that case, rainfall would be 90mm/24 hrs.

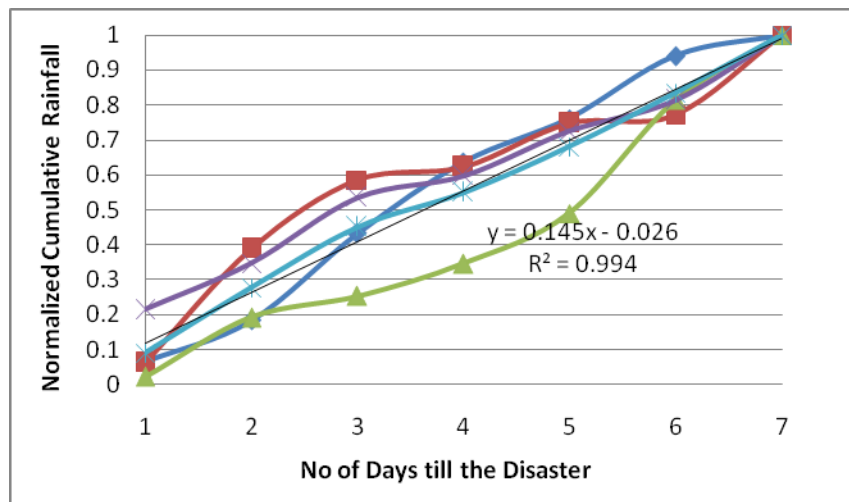
Figure 10: Normalized cumulative rainfall data for Cox's Bazaar

Methodology to use this proposed method by Nawagamuwa et al (2011) is as follows. Lets consider the relationship found for Cox's Bazaar. This gives a relationship between (Cumulative rainfall/cumulative rainfall on the day of disaster) and no of days (from 6 days prior to the disaster)

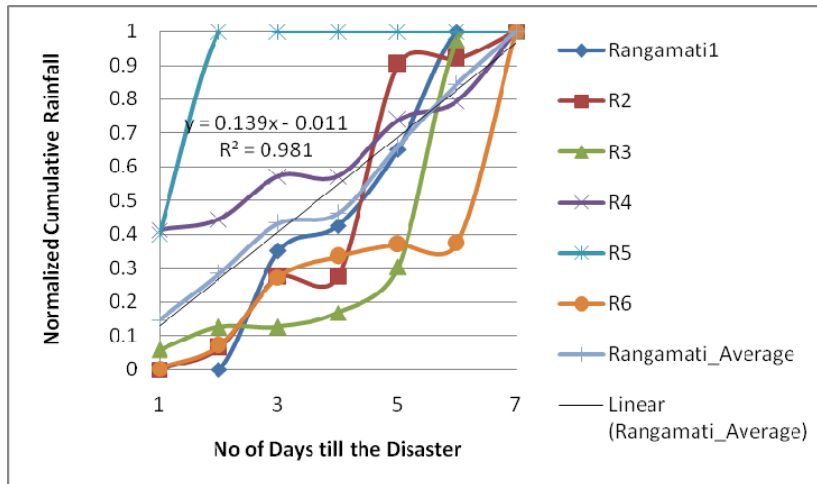
Figure 12: Normalized cumulative rainfall data for Rangamati Similar analysis was done for Chittagong too.

Data of these Rangamati and Chittagong areas do not provide conclusive thresholds as Cox's Bazaar and Teknaf. However, 200mm rainfall within last 48 hrs could be considered for this area.
